Historic Graffiti Survey of Kibworth Harcourt Windmill, Leicestershire

**Kibworth Harcourt Windmill,
Windmill Farm, Langton Road, Kibworth Harcourt, LE8 0PR**

**James Wright FSA
Triskele Heritage, Sneinton, Nottinghamshire**

July 2021

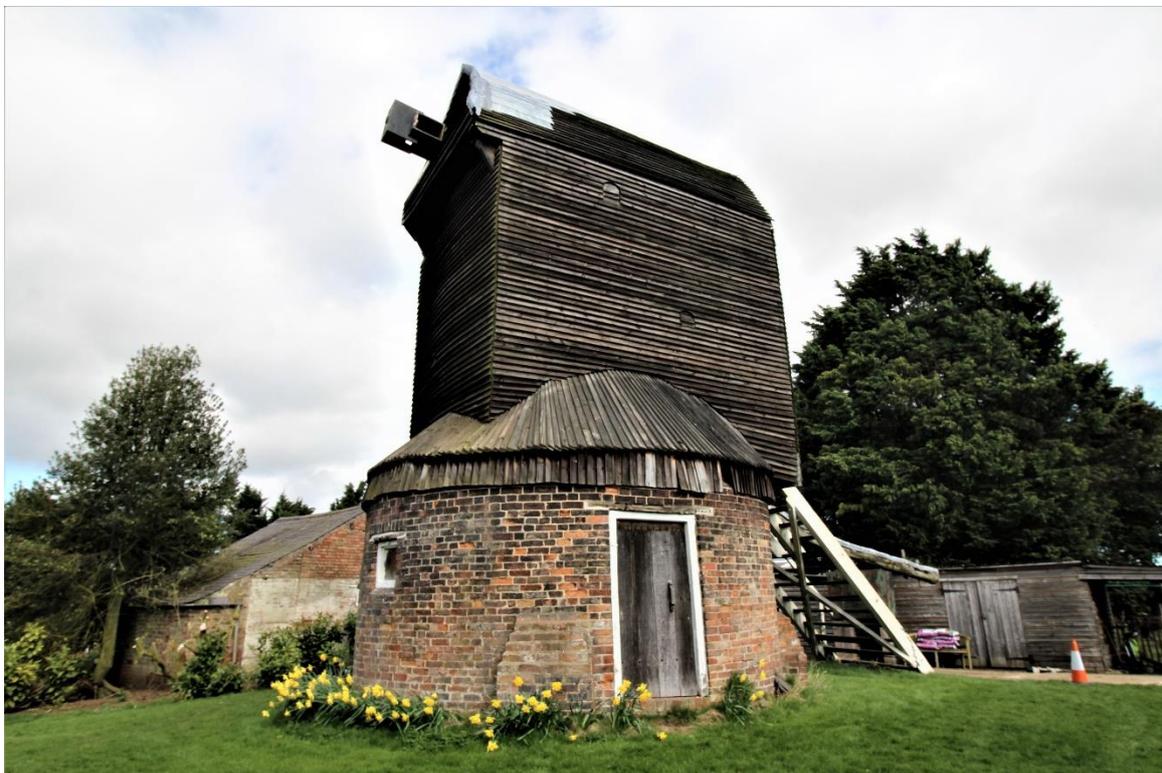
Figure 2 Kibworth Harcourt Mill, looking north-east

Kibworth Harcourt Mill is a three-storey building standing on the crest of a hill, 123 metres Ordnance Datum, approximately 275 metres to the east of edge of the built environment of the adjacent village (Figure 1). It consists of a brick-built ground floor roundhouse, accessed via doors to the north and south, which contains the main post, cross-trees and quarter bars. Above is the timber-framed and weatherboarded buck. The stable doors of the first floor to the buck are accessed from a ladder beneath the tail pole. Internally, the buck contains the meal floor, below a stone floor, which is also accessed via a ladder. The building is roofed with weather boards and the poll end remains in situ, although the windmill sails have been removed.

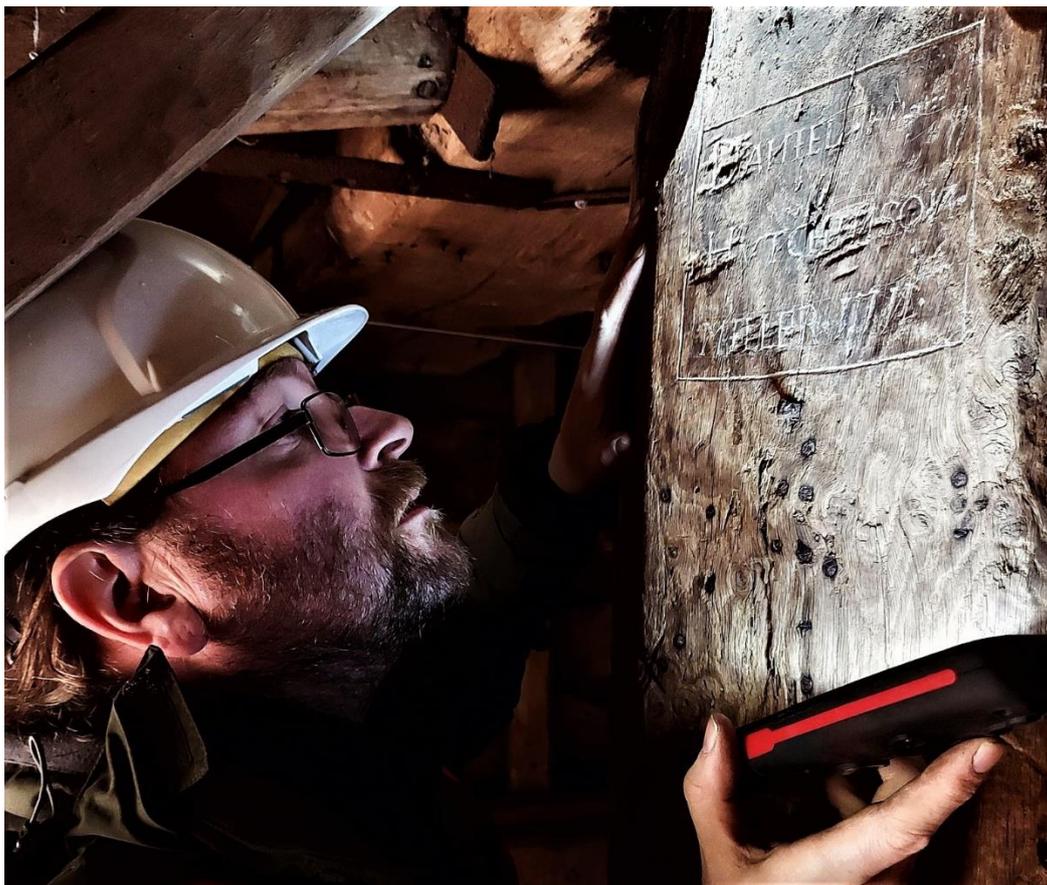
Figure 4 The author of this report using the raking light technique to observe and record graffiti at Kibworth Windmill

The graffiti survey of Kibworth Harcourt Mill took place in May 2021 and was compliant with a risk assessment generated by Prospect Engineering Ltd for the Society for the Protection of Ancient Buildings (PCE Ltd 2021). The author of this report led the recording work on the first and second floors and was assisted on the ground floor by Fiona Moore. Each archaeologist was working in low lighting levels, controlled by closing doors and windows according to need, to ensure that the raking light of torches would pick up the graffiti inscriptions. Working systematically around each space, all accessible surfaces of the building were visually surveyed (Figure 4). When a graffito was observed, it was photographed using either a Canon EOS 1200D or a Nikon D5300. The graffito was then recorded on a Triskele Heritage Historic Graffiti Survey Sheet which logged the photograph numbers, location of the inscription and a description of the graffiti. Finally, the photograph number of each graffito was located on plans and elevations of the building (see the Appendix to this report).

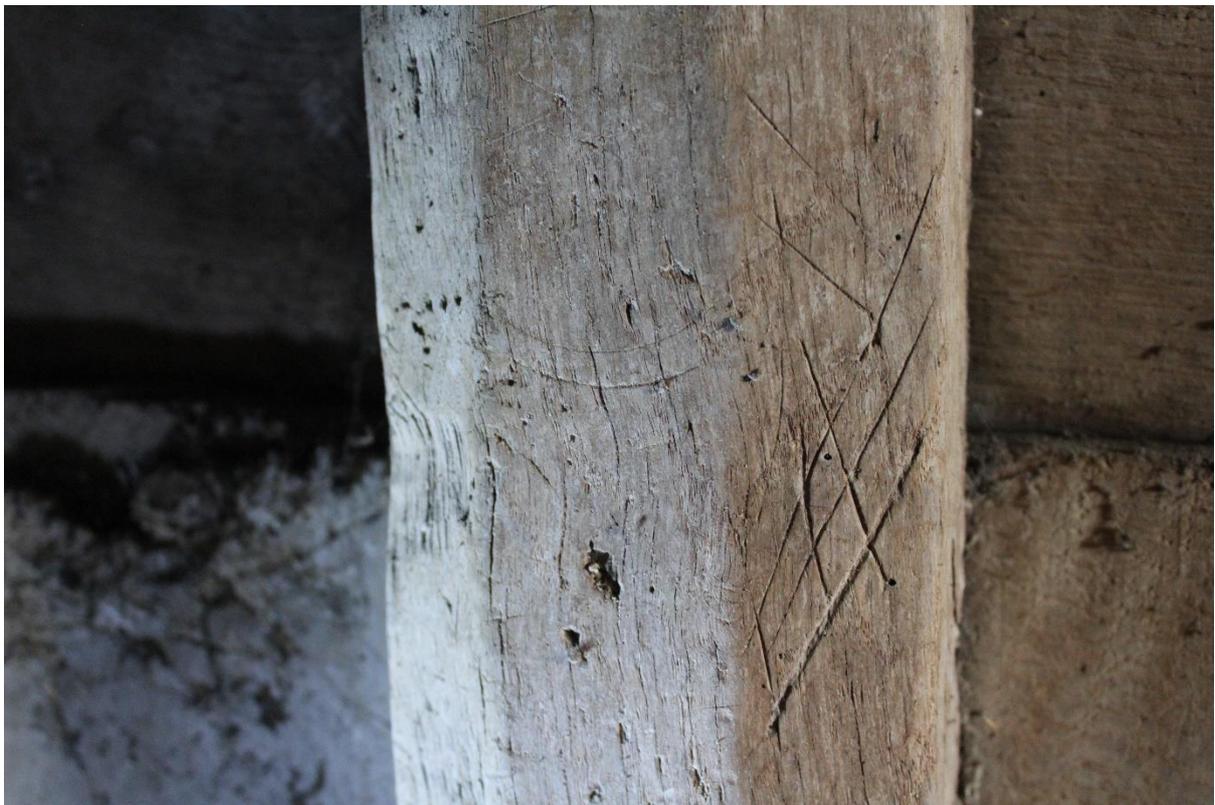
Figure 10 Partial circle and mesh pattern on a stud in the north elevation, note the chamfers

As noted in section 8.3.1 a tradition emerged during the mediaeval and early modern periods which favoured the protective power of endless line designs. A simple version of this phenomenon are the 3 mesh patterns which were found on the north elevation of the first floor. Two were on the mostly westerly stud located below the rail and one such example may have been created using a carpenter's rase knife - which leaves a half round profile (Figure 10). Other examples of carpenters creating apotropaic marks have been noted at Knole (Wright 2019, 78). It is perhaps noteworthy that the Kibworth examples were found in the vicinity of a partial circular design (Figure 10; see section 8.3.1) and a burn mark (Figure 11; see section 8.3.3).

beneath the north elevation rail at first floor are probably reused from another structure. This can be proposed by reference to the presence of chamfers on many of the timbers – an unnecessary architectural flourish in such a low status part of the building – however, it is the presence of an upside-down burn mark and dated graffito (1757) which really helped to confirm that these timbers had probably come from elsewhere.

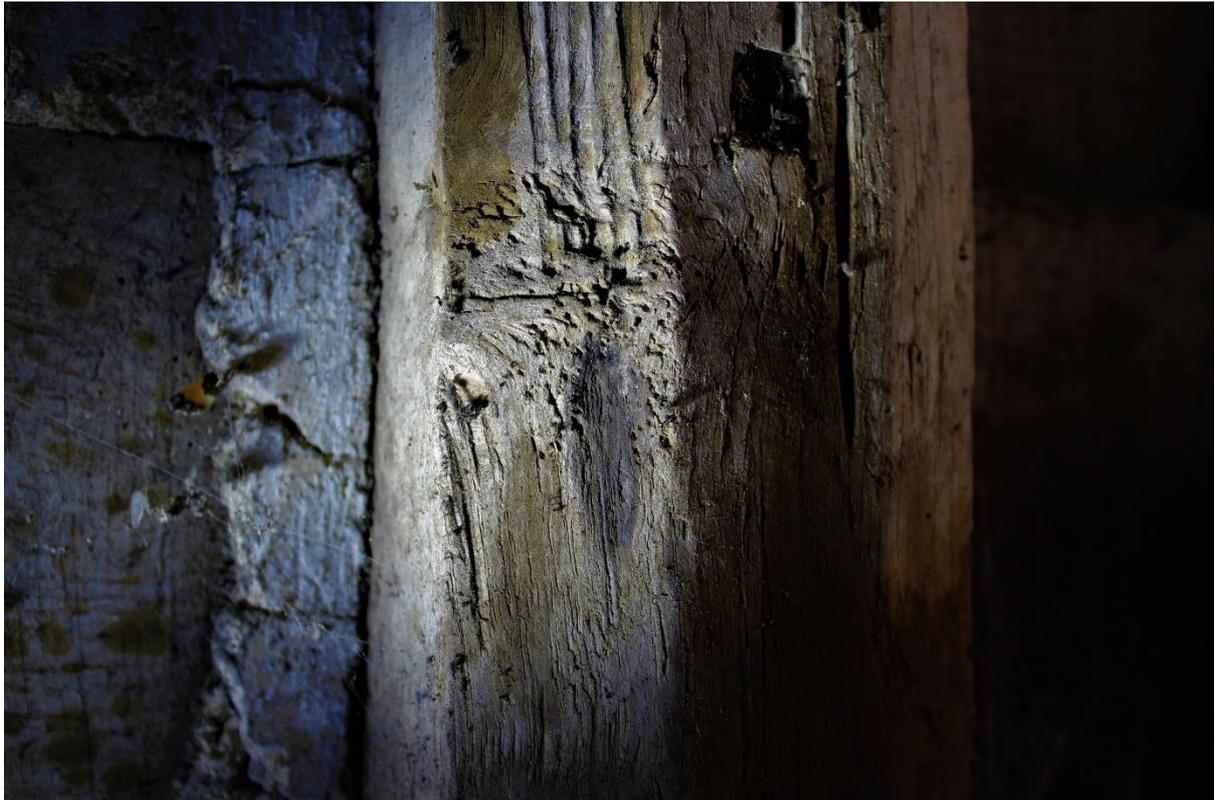
Figure 11 Burn mark, upside down, on a stud in the north elevation, note the chamfers

The implications of a burn mark which was observed to be upside-down (with its tapered point facing downwards) is discussed in section 8.3.2 (Figure 11).

However, further questions must be raised about this discreet assemblage. The burn mark is upside-down as is the adjacent graffiti which reads: "TO 1757" (Figure 12). The studs below the rail in this part of the windmill are all unusually chamfered on both external corners. Both observations are suggestive that the timbers may have been reused from another structure and the graffiti has migrated from elsewhere. This is given further credence by the results of the dendrochronological survey which indicate that the buck was constructed in 1773 (Arnold, Howard & Litton 2004, 3-4) – 16 years after the dated graffiti.

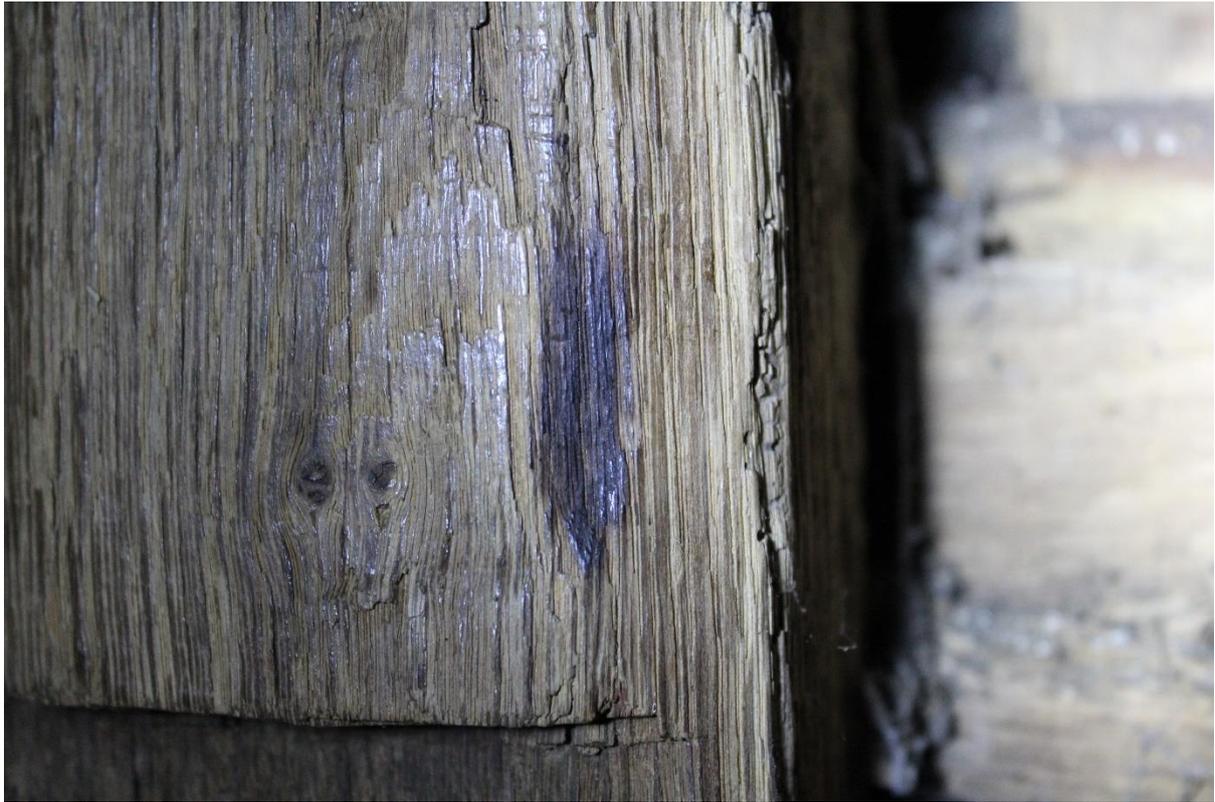
Figure 13 Burn mark on the stud to the west of the second floor window of the north elevation

Burn marks are the second most common form of apotropaic marks at the windmill with 19 examples recorded (7.19%). Of these, the majority (12) were found on the second floor (Figure 13). Alike to the other forms of apotropaic graffiti, burn marks are also well known in mediaeval and early modern contexts. The earliest known examples come from Donington-le-Heath Manor House (Leicestershire) and have been dated to the late thirteenth century (Fearn 2017, 102-09) with the latest coming from the 1870s at Knole (Wright 2016, 11, 25, 26). It used to be commonly thought that tear-shaped burn marks were caused, inadvertently, by unattended rushlights, tapers or candles – for example in the interpretation at Haddon Hall in Derbyshire (Cleary 2014, 33). However, peer-reviewed, experimental archaeology has demonstrated that the characteristic tear-shaped marks cannot be created accidentally – instead they are the result of deliberate human behaviour in which a light is held steadily at a 45 degree angle for between 5 and 20 minutes (Dean & Hill 2014).

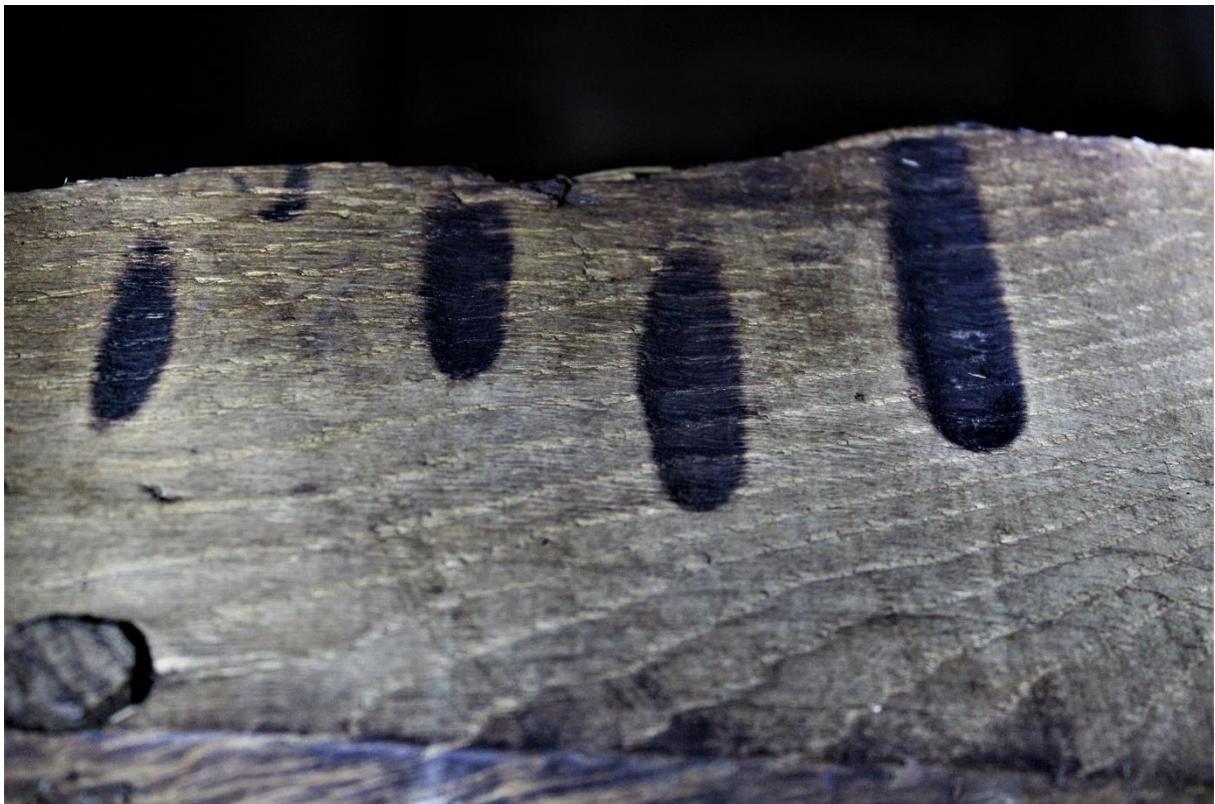
Figure 14 Group of 4 burn marks on the wall plate of the west elevation

One of the most interesting assemblages of burn marks in the windmill is the group of 4 which sits on the western wall plate directly behind the gear wheel (Figure 14). Such liminal places, especially in roof structures, have also been noted as a classic location for burn marks as they were areas of buildings which were dark and may have also been considered vulnerable to spirits (Lloyd, Dean & Westwood 2001, 57).

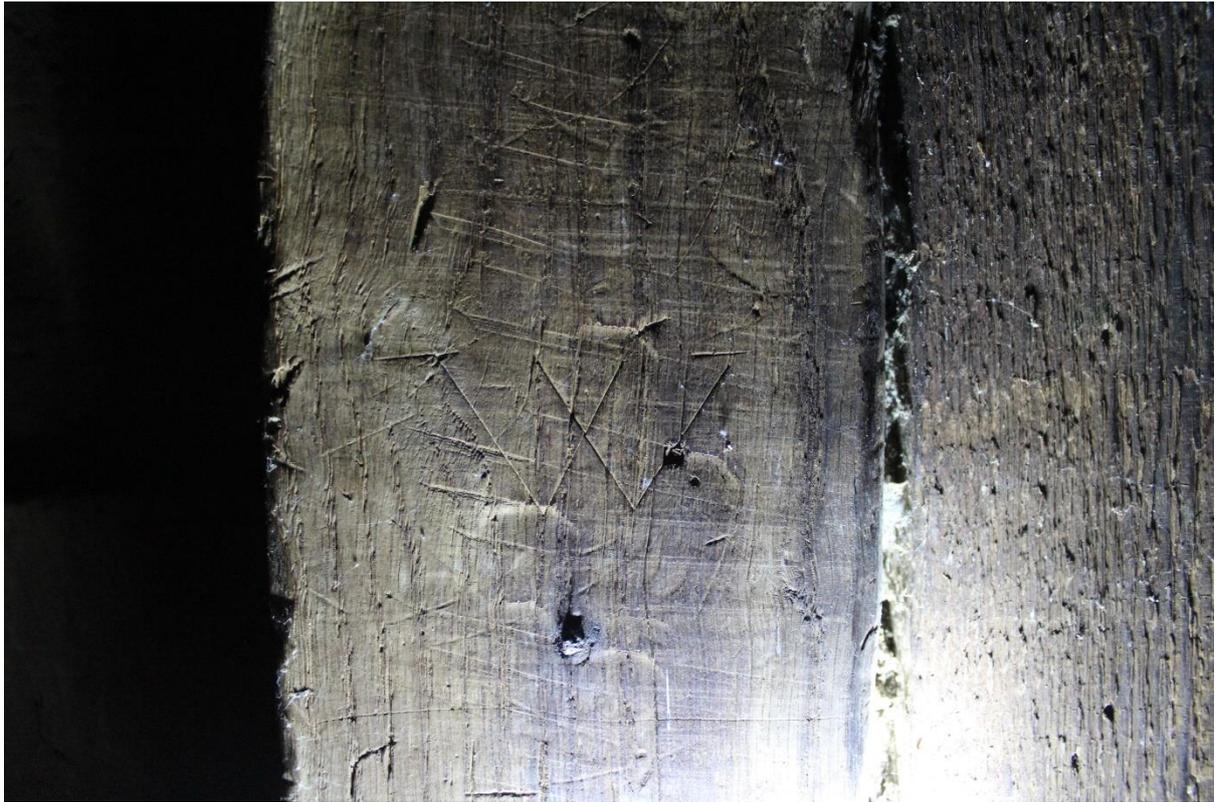
Figure 15 Conjoined VV mark on the north door jamb

At Kibworth Windmill the only conjoined VV mark was found on the northern door jamb in close association with three circles or rosettes (Figure 15). It was unlike any other representation of the letter “W” in the building and the combination of its form, location and proximity to other apotropaic marks indicates the potential that it should be considered in the apotropaic category.

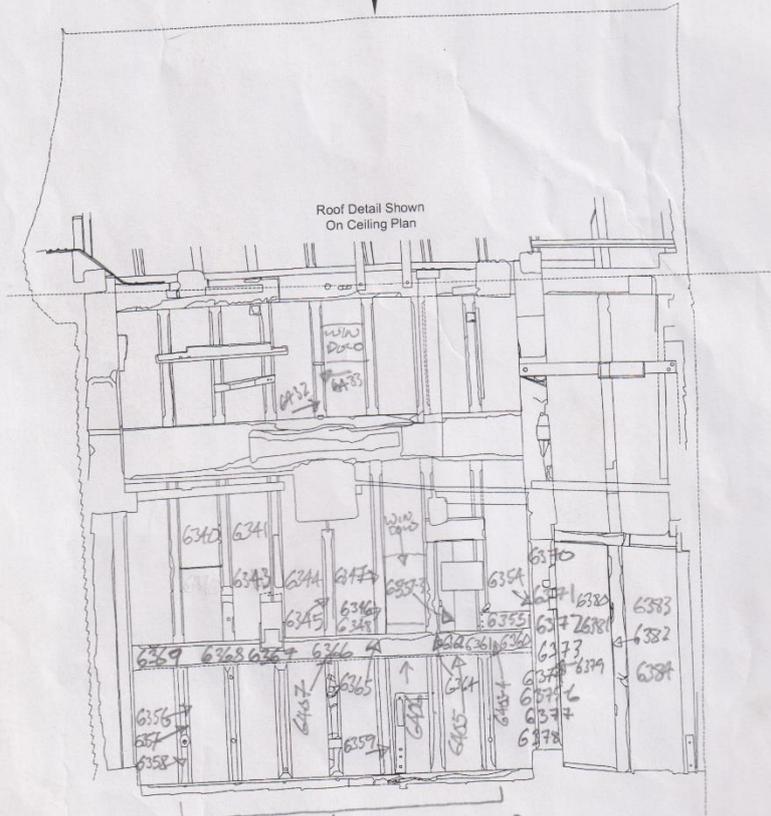
FIRST FLOOR
PLAN

Studs are chamfered & have relief for uds & graffiti
Ground Floor Not Shown
