Collingham Uncovered

Level 1 historic building survey of selected structures in Collingham, Nottinghamshire; incorporating assessments of 12 Bell Lane and 6 Westfield Lane

Dr James Wright FSA,
Triskele Heritage, Sneinton, Nottinghamshire

January 2023

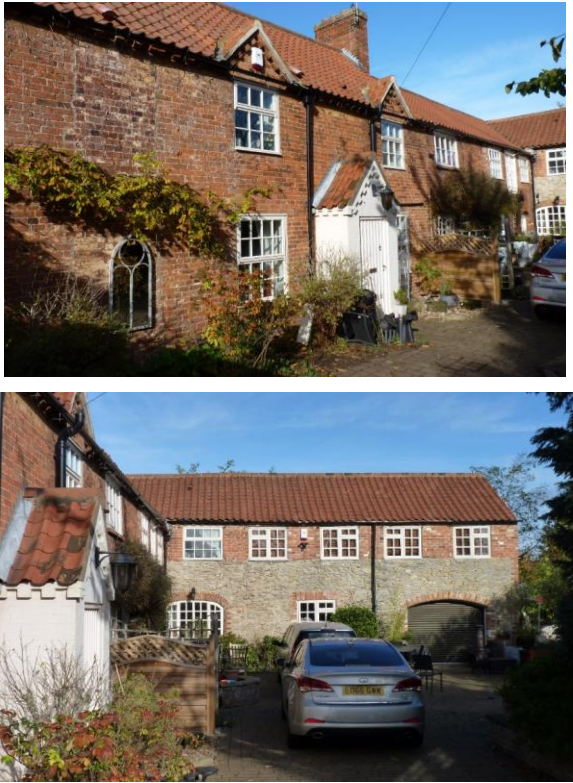
Address	Wicksted Lodge 4 Bell Lane North Collingham	
Grid Reference	SK 82933 61610	
Listing	None	
Building Code	BELL4	
Description	House and Barn/Coach house, early modern with extensive C19 alterations; coursed blue Lias rubble and brick; gabled pantile roof, single ridge, and single wall stacks. 2 storeys.	
Photograph

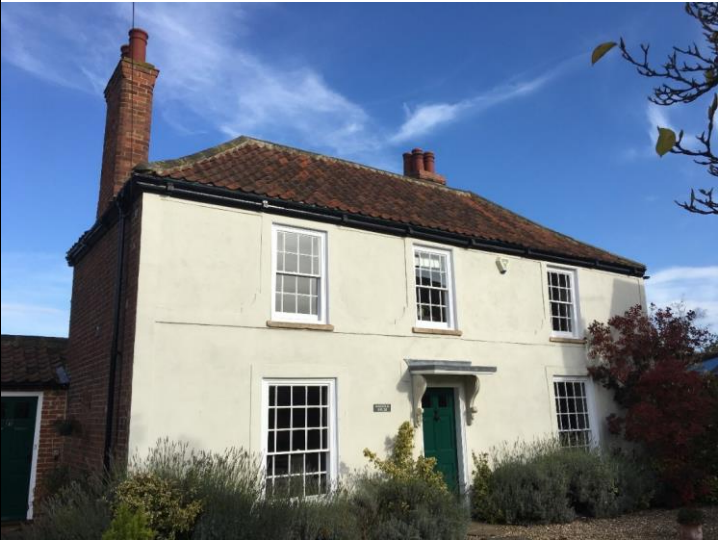
Address	The Nook now Magnolia House 12 Bell Lane North Collingham	
Grid Reference	SK 82890 61623	
Listing	Grade II 1046066 17 October 1984	
Building Code	BELL12	
Description	"House, C17 with extensive C19 alterations; coursed blue Lias rubble and brick, rendered and colourwashed; hipped pantile roof, single ridge, and single wall stacks. 2 storeys, 3 windows., cellar. Central moulded timber doorcase with hood, flanked by single C19 glazing bar sashes; above 3 similar sashes. Interior has considerable remains of timber framing."	
Photograph

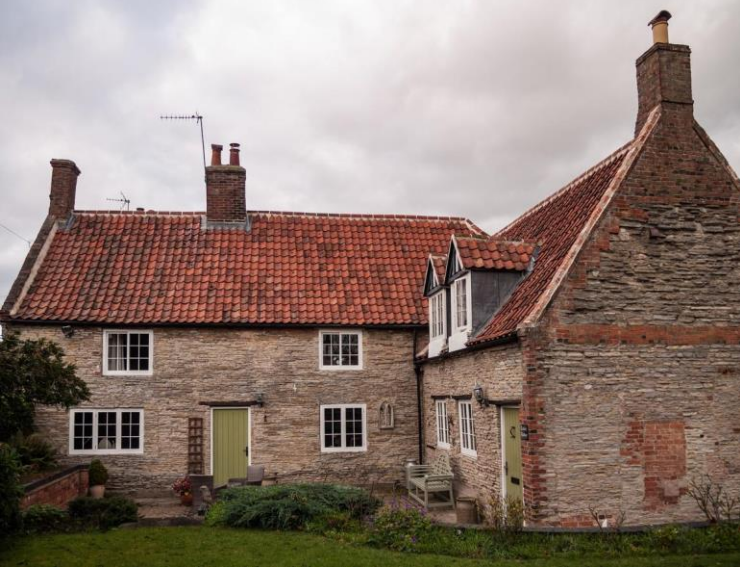
Address	Tudor Cottage 15 Dykes End South Collingham	
Grid Reference	SK 83042 61378	
Listing	Grade II 1156836	
Building Code	DYKES 15	
Description	<p>"House, C17, with C20 alterations; coursed blue Lias rubble and brick, pantile roof, brick dressings, brick coped gables, 2 gable stacks, single ridge stack, 2 brick bands on east gable. 2 storeys, L-plan. West wing has central C20 door flanked by single 2 light casements; above, 2 similar casements; south gable has single blocked opening on each floor and above, wall ties with initials 'I.G.' South front has C20 door to east and to west, 2 C20 2 light leaded casements; above, 2 C20 gabled dormers, each with 2 leaded casements."</p>	
Photograph

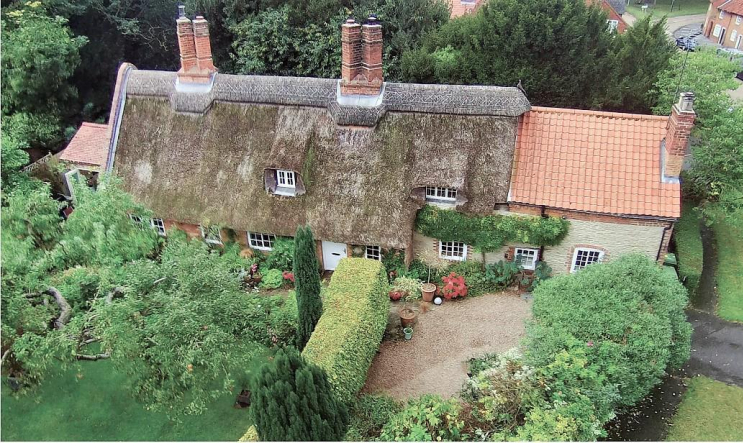
Address	The Thatched Cottage 3 The Green South Collingham	
Grid Reference	SK 82890 61319	
Listing	Grade II 1369947	
Building Code	Green Thatched Cottage	
Description	<p>"GV II* Cottage, late C16 and late C17 with late C18 extension to north. Brick on rubble plinth and timber framed with steep pitched thatched roof and shallow pantile roof, two pairs of large C19 ridge stacks. One and a half storeys, five bays. Off-centre C20 timber porch with C20 half glazed door flanked by two C19 two-light Yorkshire sashes, that to north with segmental head; to south C20 single glazing bar top hung casement and single C20 three-light glazing bar casement, both with timber lintels. South gable has C19 gabled brick porch with C19 single light glazing bar casement above. C18 extension to north, coursed blue Lias rubble and brick, dentillated eaves, pantile roof, single gable stack. Single storey with garret. A single C19 single light top hung casement and a single C19 two-light Yorkshire sash with segmental head. In the north gable, a single C19 three-light Yorkshire sash. Interior has substantial remains of an aisled hall or barn, with arched braces and blackened timbers. Some stud partitions, the C17 timber staircase, and chamfered spine beams also survive. Outside, boundary wall, C18. Coursed blue Lias rubble with rubble coping. Ramp changing height from approximately 1 metre to approximately 1.5 metres."</p> <p>Roof structure tree-ring dated 1404.</p>

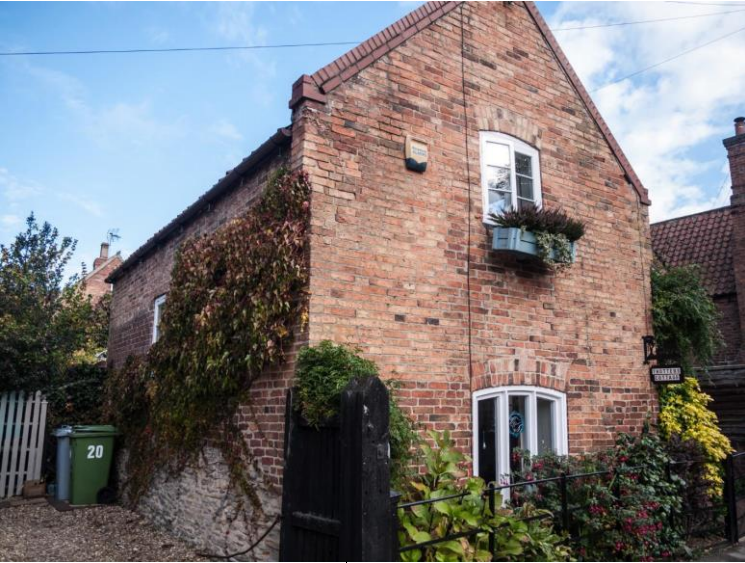
Address	Trotters Cottage 10 The Green South Collingham	
Grid Reference	SK 82893 61362	
Listing	Not listed	
Building Code	Green 10	
Description	Possible early modern. Originally a barn attached to Yew Tree Farmhouse. Gable end with roof parapets. Stands end on to the road. Blue Lias evident on lower wall.	
Photograph

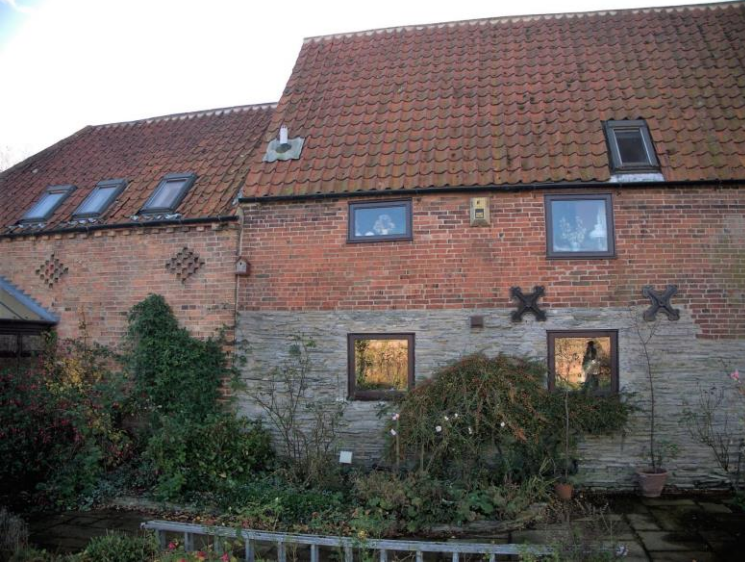
Address	The Barn 12 The Green South Collingham	
Grid Reference	SK 82824 61384	
Listing	Not listed	
Building Code	Green 12	
Description	Possible early modern. Originally a barn part of Yew Tree Farm complex. Pantile roof with parapets. Blue Lias evident on lower walls. End of tie beam visible in gable end wall.	
Photograph

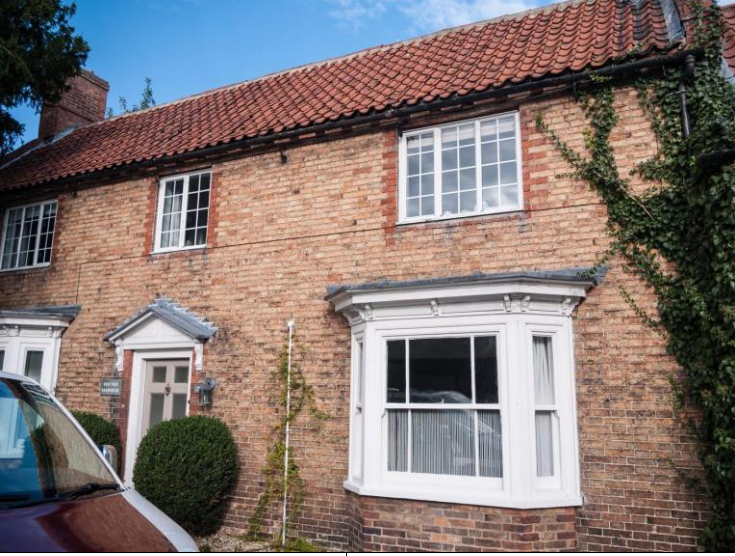
Address	Yew Tree Farm House 20 The Green South Collingham	
Grid Reference	SK 86 82876 61361	
Listing	Grade II 1046073	
Building Code	Green 20	
Description	<p>"Farmhouse C17, remodelled late C18 with C19 addition to east. Buff brick with red brick dressings, pantile roof, brick coped gables, 2 gable stacks; 2 storeys, 3 windows, L-plan. Central pedimented C20 timber porch containing C19 half glazed door with scroll brackets supporting pediment, flanked by single C19 canted timber bays with flat lead roofs and margin-light sashes. Above, 3 C20 aluminium glazing bar sashes. C19 addition to east with steep pitch pantile roof, coped gable, dentillated eaves, single gable stack. Central C20 plain sash; rounded corners on east end. Rear wing C17, coursed blue Lias rubble and brick, timber post at north-east corner; cogged eaves, eaves band, single ridge stack, irregular C20 fenestration."</p>	
Photograph

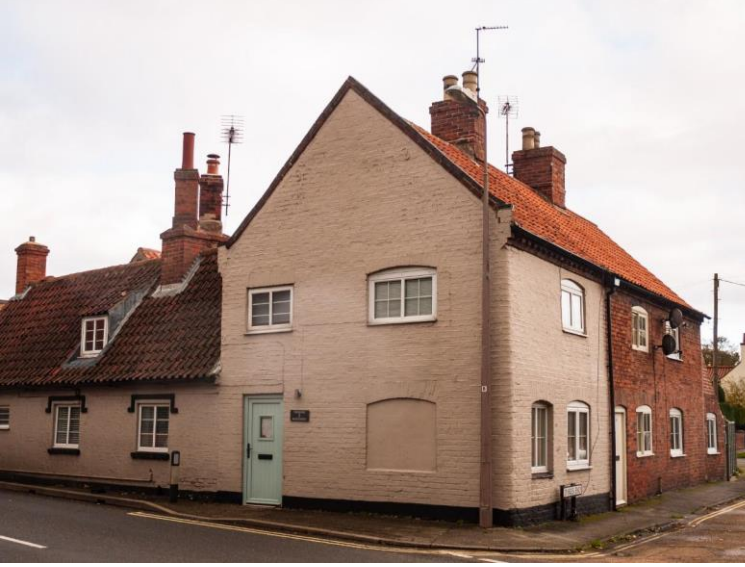
Address	The Nook 2 High Street South Collingham	
Grid Reference	SK 82956 61374	
Listing	Not listed	
Building Code	High 2	
Description	Cottage, seventeenth or eighteenth century. Timber framing visible in interior as photographed by estate agents.	
Photograph

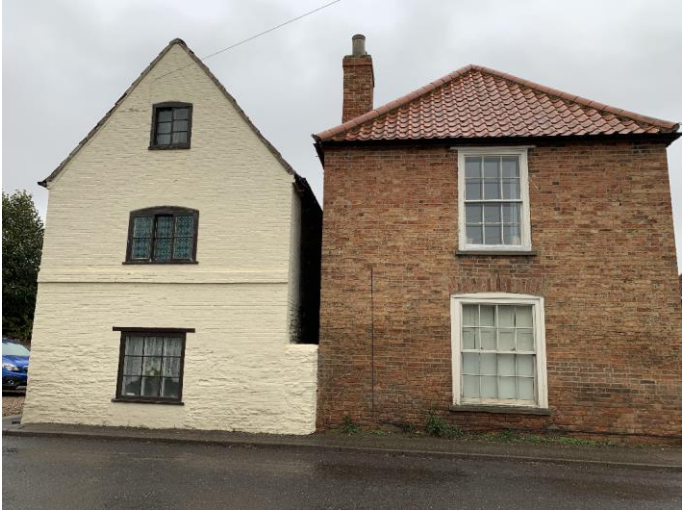
Address	20 High Street Collingham	
Grid Reference	SK 82984 61465	
Listing	Grade 2 UID 1046037	
Building Code	HIGH20	
Description	<p>"House, C17 with C18 and C19 additions. Coursed and squared rubble and brick: hipped pantile roof, brick eaves, stone sills, single wall, single ridge and single gable stacks. West front, 2 storeys, one bay has single C18 glazing bar sash with segmental head; above, another similar sash; south side has similar windows in similar arrangement. Rear range, C17, 1½ storeys, single coped gable, has to west C18 part-glazed door flanked to east by C20 brick and timber bay window. Above, dormer containing 3 light Yorkshire sash. C19 projecting wing to east, 1 storey, 1 bay, has single C19 fixed light and C19 glazing bar sash. South gable has C19 half-glazed door and C19 shop window."</p>	
Photograph

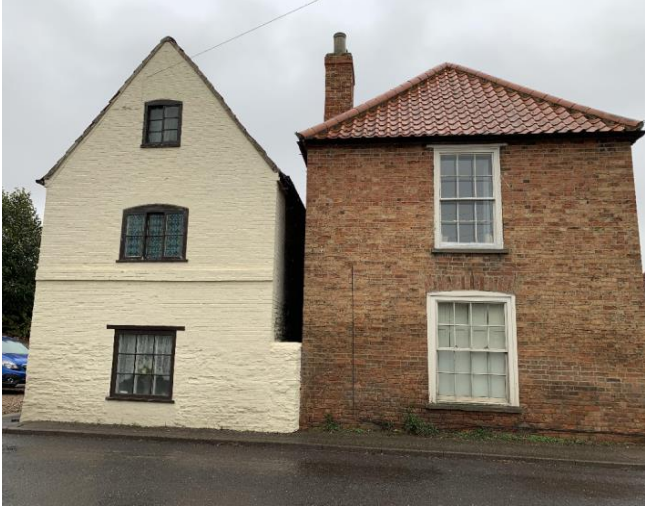
Address	Woodgate 22 High Street Collingham	
Grid Reference	SK 82988 61471	
Listing	Grade 2 UID 1369930	
Building Code	HIGH22	
Description	<p>"House, early C18 with C20 rear extension. Coursed blue Lias rubble and brick, pantile roof, single ridge stack, first floor band on west gable; colourwashed. Rear extension rendered and with imitation timber framing. 2 storeys plus garrets, L-plan. West gable has single C19 fixed light; above, C19 3 light Yorkshire sash; above again, 2 light Yorkshire sash, both with segmental heads. North front has to east C20 weatherboarded porch, flanked to west by 2 C19 3 light Yorkshire sashes. Above, single 2 light casement. Rear extension has, above, single 2 light casement."</p>	
Photograph

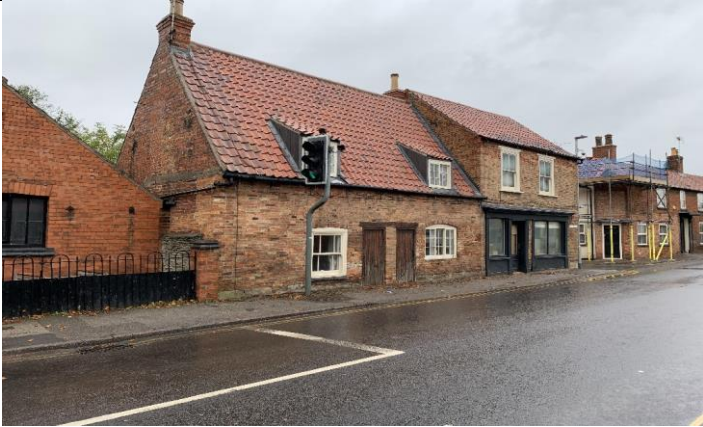
Address	37 High Street Collingham	
Grid Reference	SK 82983 61574	
Listing	Grade 2 UID 1046076	
Building Code	HIGH37	
Description	<p>"Pair of cottages, 1744 and C18, with C19 alterations. Brick with steep pitched pantile roof, 2 gable stacks, 1½ and 2 storeys, 4 bays. South range has paired central C19 close boarded doors with common timber lintel, flanked to south by C19 margin pane sash with segmental head, to north by single fixed light in modified segmental head; above, 2 dormers with single Yorkshire sashes. 2 storey range to north has off-centre C20 glazed door flanked by single C19 shop windows; above, 2 plain sashes. North gable has C19 shop window and, above, single plain sash. Lean-to rear extension. Rear elevation and interiors have considerable remains of timber framing."</p>	
Photograph

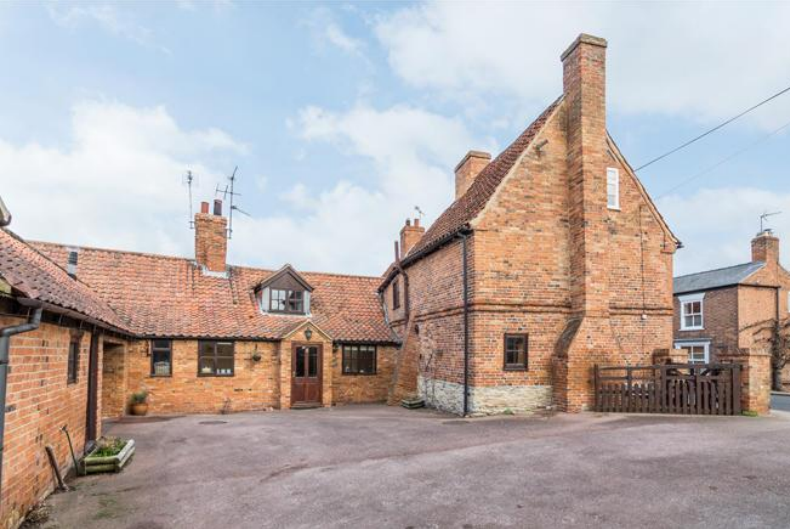
Address	55 High Street North Collingham	
Grid Reference	SK 83007 61669	
Listing	Grade II 1302663	
Building Code	High 55	
Description	<p>"Pair of houses, C18, refaced C19. Coursed blue Lias rubble and brick, steep pitched pantiled roof, first floor brick band on south gable and rear, eaves band on north gable, 2 ridge stacks, one external gable stack. 2 storeys plus garrets, 4 windows. Southern facade has off-centre C19 half-glazed door, flanked to south by 2 pane shop window and door above, single C19 2 light Yorkshire sash and single smaller Yorkshire sash. South gable has single C19 glazing bar casement, and in garret 2 light Yorkshire sash. Northern facade has central C19 panelled door flanked by single margin pane sashes with segmental heads; above, 2 similar sashes. North gable has single C20 fixed light; above, single C19 2 light Yorkshire sash; above again, wall ties in the form 'W D'. C19 extensions to rear now in separate occupation."</p>

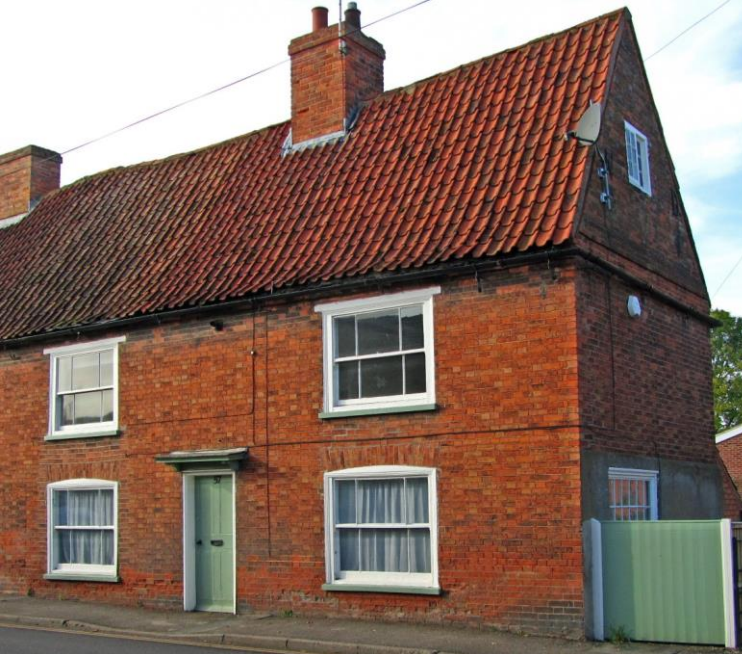
Address	57 High Street North Collingham	
Grid Reference	SK 83009 61679	
Listing	Grade II 1302663	
Building Code	High57	
Description	<p>"Pair of houses, C18, refaced C19. Coursed blue Lias rubble and brick, steep pitched pantiled roof, first floor brick band on south gable and rear, eaves band on north gable, 2 ridge stacks, one external gable stack. 2 storeys plus garrets, 4 windows. Southern facade has off-centre C19 half-glazed door, flanked to south by 2 pane shop window and door above, single C19 2 light Yorkshire sash and single smaller Yorkshire sash. South gable has single C19 glazing bar casement, and in garret 2 light Yorkshire sash. Northern facade has central C19 panelled door flanked by single margin pane sashes with segmental heads; above, 2 similar sashes. North gable has single C20 fixed light; above, single C19 2 light Yorkshire sash; above again, wall ties in the form 'W D'. C19 extensions to rear now in separate occupation."</p>

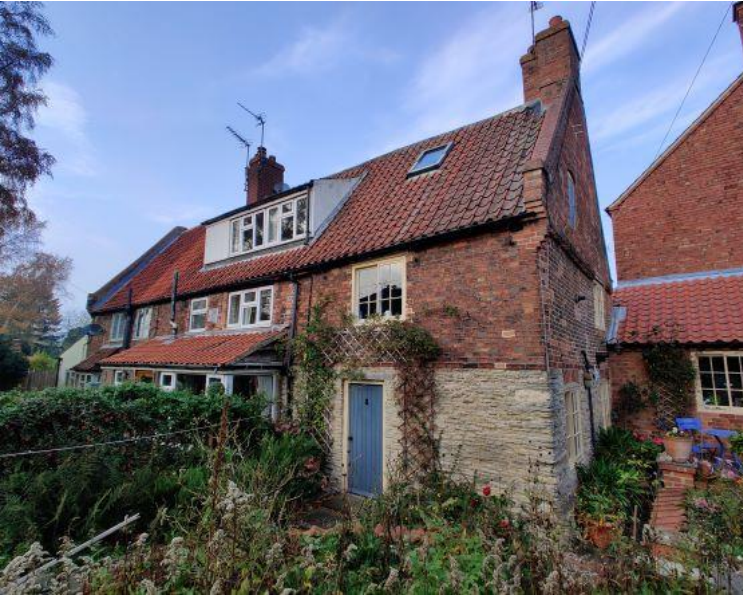
Address	75,77,79 High Street North Collingham	
Grid Reference	SK 83017 61761	
Listing	Not listed	
Building Code	High 75/77/79	
Description	Now three cottages possible early modern. Would have been thatched, now pantiles. Suspect timber framing evident inside. Blue Lias at base of walls.	
Photograph

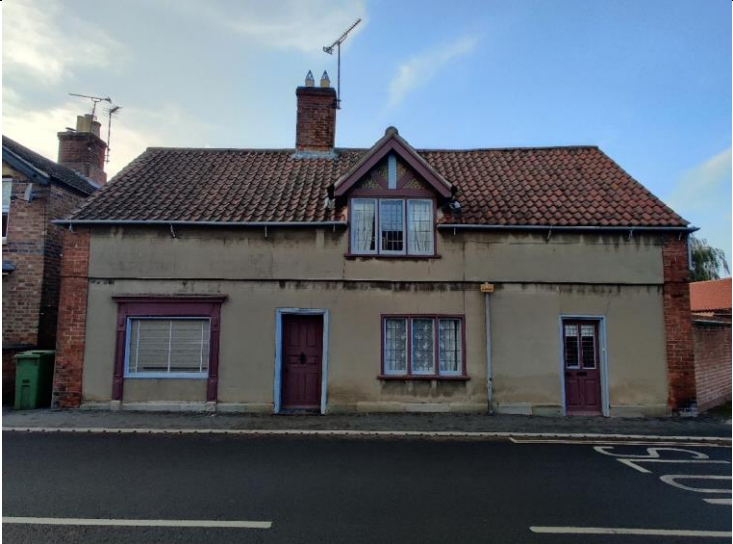
Address	87 High Street Collingham	
Grid Reference	SK 83036 61791	
Listing	Grade 2 UID 1046077	
Building Code	HIGH87	
Description	<p>"Pair of cottages, 1656, with C20 alterations; now one property. Coursed and squared rubble and brick, timber framing, rendered. C20 pantile roof, single ridge stack. 1½ storeys, 2 bays. Pair of similar facades, that to south has C19 moulded architrave containing panelled door, flanked to south by single shop window; that to north has C19 half-glazed door, flanked to south by C19 3 light leaded casement. Above, single central C20 gabled dormer with 3-light leaded casement. North gable has 2 C20 fixed lights; above single 2-light casement."</p>	
Photograph

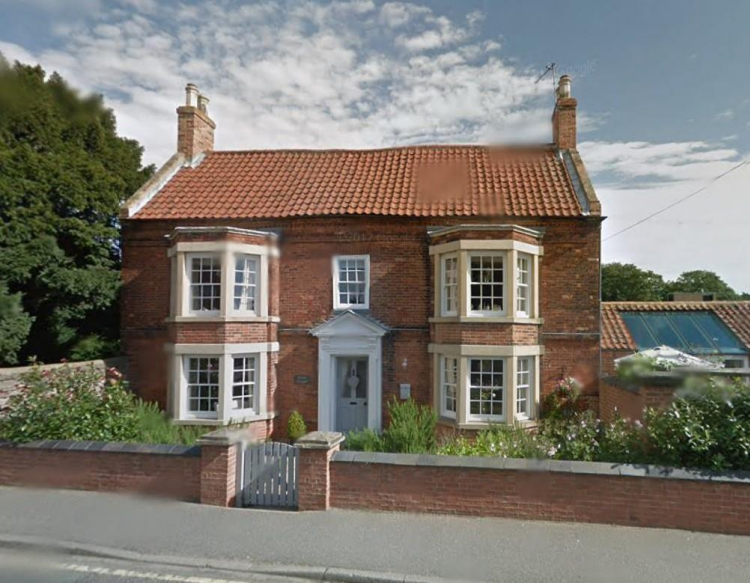
Address	Bank House 94 High Street North Collingham	
Grid Reference	SK 83073 61868	
Listing	Grade II 1046038	
Building Code	High 94	
Description	<p>"II G.V. House, C18, with C19 additions. Coursed blue Lias rubble and brick, pantile roof, ashlar and moulded brick dressings; 2 gable stacks, brick coped gables with pale headers, brick first floor and eaves bands. 2 storeys plus garrets, L-plan. Central C18 moulded doorcase with scroll brackets to moulded triangular pediment, containing C19 half-glazed door, flanked by 2 C19 2 storey canted bay windows, each with 3 C19 glazing bar sashes. Above, central C18 glazing bar sash with rubbed brick head, flanked by bay windows each with 3 C19 glazing bar sashes, lead roofs and parapets. South gable has in garret, 2 light glazing bar sash. Brick boundary wall with blue brick coping, 2 piers with pyramidal stone caps."</p>	
Photograph

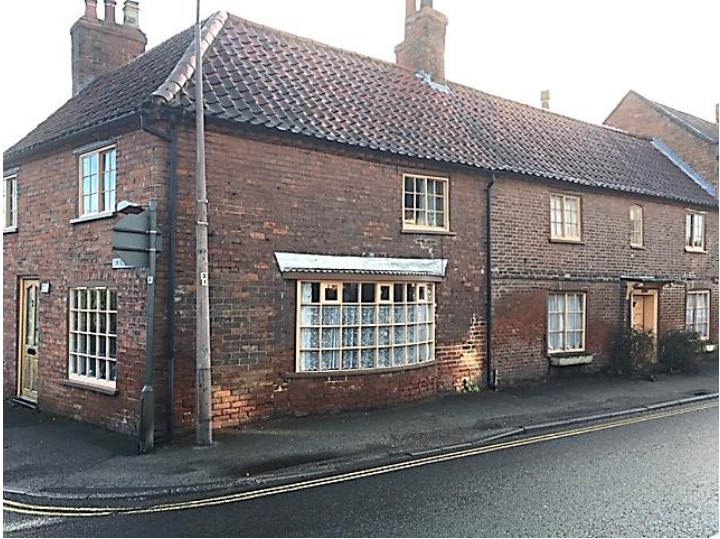
Address	100 High Street Collingham	
Grid Reference	SK 8307861899	
Listing	Grade 2 UID 1334938	
Building Code	HIGH100	
Description	<p>"House. c.1700, raised late C18, with minor C19 alterations. Red brick with dentillated eaves and pantile roofs. Single ridge and single rear wall stack. 2 storey. First floor brick band. Street front has 3 windows. Central doorway with wooden moulded surround and bracketed hood. To left a large 2-light sliding sash with glazing bars inserted within original narrower opening, and to right another 2-light sliding sash with glazing bars under a segmental head. Above central narrow window with glazing bars and segmental head, either side small 2-light sliding sashes with glazing bars. Rear catslide with C19 extension, and C20 fenestration. INTERIOR retains chamfered spine beams to ground floor rooms, C18 panels doors and C18 wooden winder staircase. Upper floor has lime-ash floors, panel doors and beams. Roof structure replaced early C20."</p>

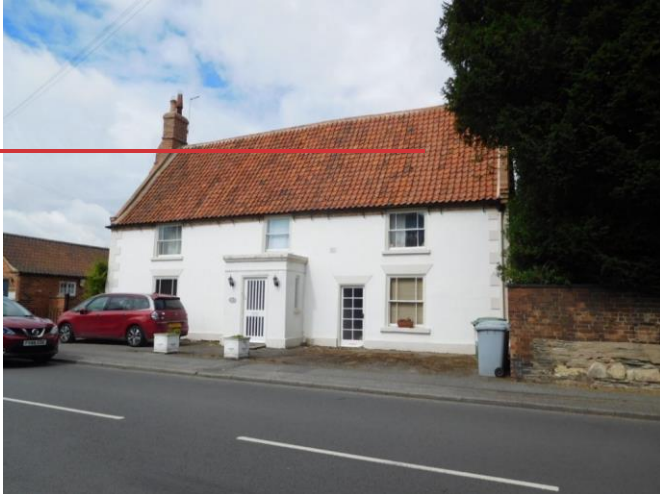
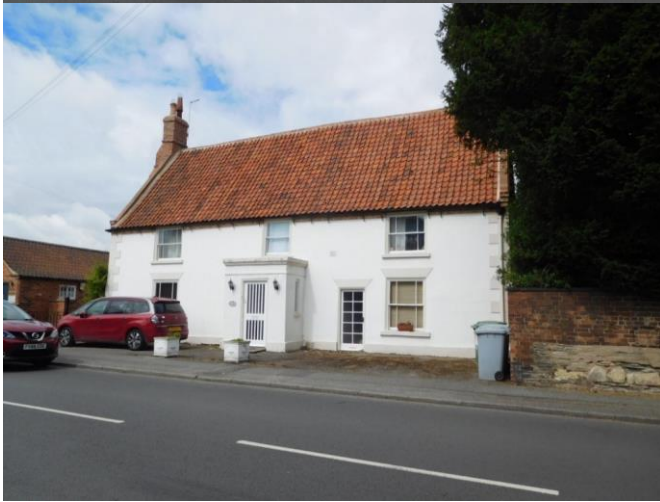
Address	Old White Hart 119 High Street Collingham
Grid Reference	SK 83072 61971
Listing	Grade 2 UID 1369911
Building Code	HIGH119
Description	“House, formerly inn, 1664, altered late C19. Coursed blue Lias rubble and brick, partially rendered, with stucco eaves and lintels, brick eaves, brick eaves band on south gable, steep pitched pantile roof, brick coped gables, 2 gable stacks, that to south external. L-plan. 2 storeys, 3 windows. Central C19 margin light sash flanked by single C19 half-glazed doors; flanked again by single C19 margin light sashes. Above, 3 C19 margin light sashes. South front has irregular C19 and C20 fenestration. Interior has oak span beam inscribed '1664 RB CB'.”

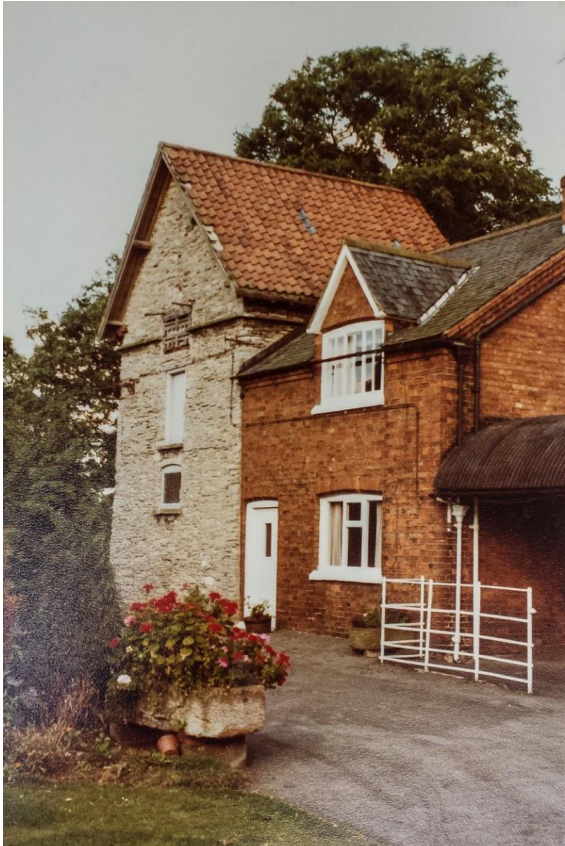
Address	Manor Farm 7 Low Street South Collingham	
Grid Reference	SK 82776 61450	
Listing	Not listed	
Building Code	Low 7	
Description	Early modern dovecote, could be earlier. Blue Lias and brick. Pantile roof. Cottage adjoining. Was part of the Manor estate. Farm buildings and barn, C18.	
Photograph

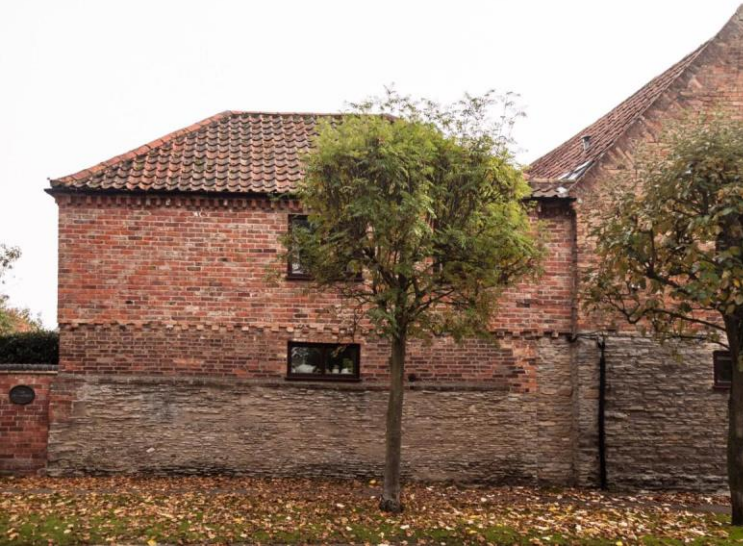
Address	12 Low Street Collingham	
Grid Reference	SK 82827 61446	
Listing	Not listed	
Building Code	Low 12	
Description	Formerly a farm building, possibly early modern. Blue Lias stonework and tumble brick coped gables. Single ridge pantiled roof.	
Photograph

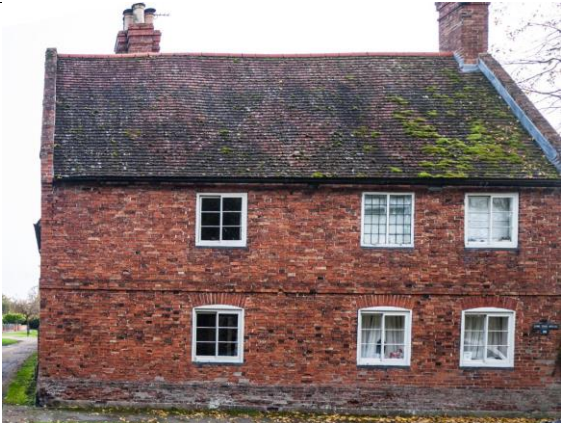
Address	Lime Tree House 14 Low Street South Collingham	
Grid Reference	SK 82835 61474	
Listing	Grade II 1369933	
Building Code	Low 14	
Description	<p>"House, C17 with C18 additions. Brick with steep pitched patterned plain tile roof, 1st floor brick band, brick plinth, tumbled brick coped gables, single ridge and 2 gable stacks. 2 storeys plus garrets, L-plan. East front, 3 bays with 3 Yorkshire sashes above, central C17 fixed light flanked by 2 Yorkshire sashes, all with segmental heads. North front, 2 bays, 2 C19 Yorkshire sashes, that in gable with segmental head; above 2 similar Yorkshire sashes; above again, single C19 leaded fixed light. East addition, C18, brick with pantile roof, rendered plinth, 2 brick bands, moulded eaves, 2 storeys 2 bays, has 2 light Yorkshire sash and single 2 light casement; above 2 light Yorkshire sash and 2 light casement. C19 outbuilding has panelled door. Rear elevation has irregular fenestration and C19 gabled brick porch. Interior has C18 doors, fireplaces with oak bressummers; garrets have gypsum floors and wattle partitions; roof has halved and pegged rafters tenoned into purlins."</p>

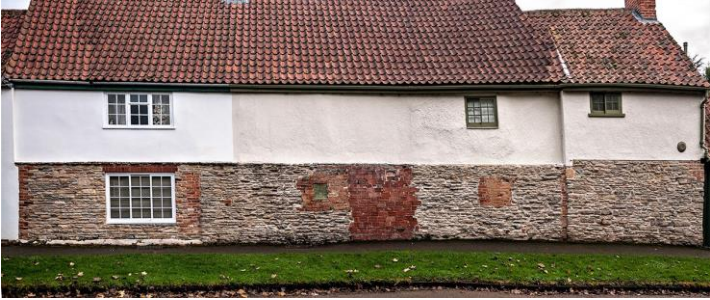
Address	The Little House 20 Low Street South Collingham	
Grid Reference	SK 82837 61525	
Listing	Grade II 1046042	
Building Code	Low 20	
Description	<p>"House, now divided into 2 dwellings, early C18 with C19 additions either end. Coursed blue Lias rubble and brick, partly rendered, pantile roof, central section steep pitched; single ridge stack and 3 gable stacks. Central section, 2 storeys, 4 bays, has off-centre C19 ogee-headed timber porch containing door with 4 glazed lancet panels, flanked to south by single C19 Yorkshire sash with segmental head, to north by re-set C18 glazing bar sash; beyond boundary wall, C20 door. Above, single C20 glazing bar casement, single Yorkshire sash and a barred C19 2 light Yorkshire sash. South addition, 2 storeys, one bay, has 3 light Yorkshire sash, above C19 2 light Yorkshire sash. North addition, 2 storeys, one bay, has C20 flush door and one C19 plain sash on each floor. Rear elevation has irregular C19 and C20 fenestration."</p> <p>Potentially built on the hall house plan and might be mediaeval or early modern.</p>

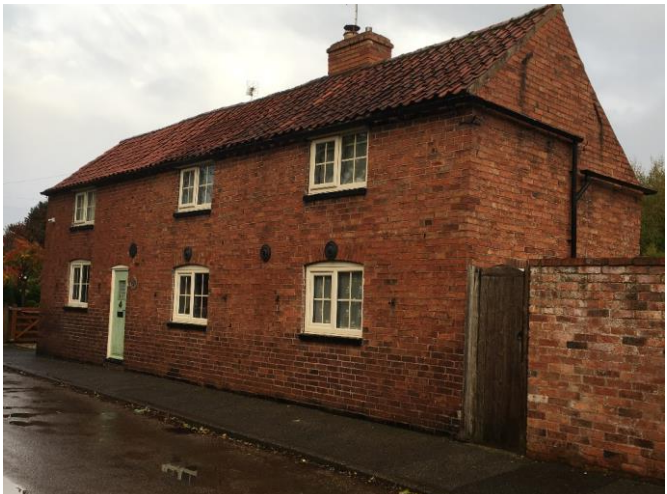
Address	Fleet Cottage 30 Low Street North Collingham	
Grid Reference	SK 82832 61655	
Listing	None	
Building Code	Low 30	
Description	Originally two cottages now combined to form a single dwelling. Timber framing evident, stone Lias at base of walls. At one time was the western dwellings to a terrace of cottages to the south east. Likely to be early modern.	
Photograph

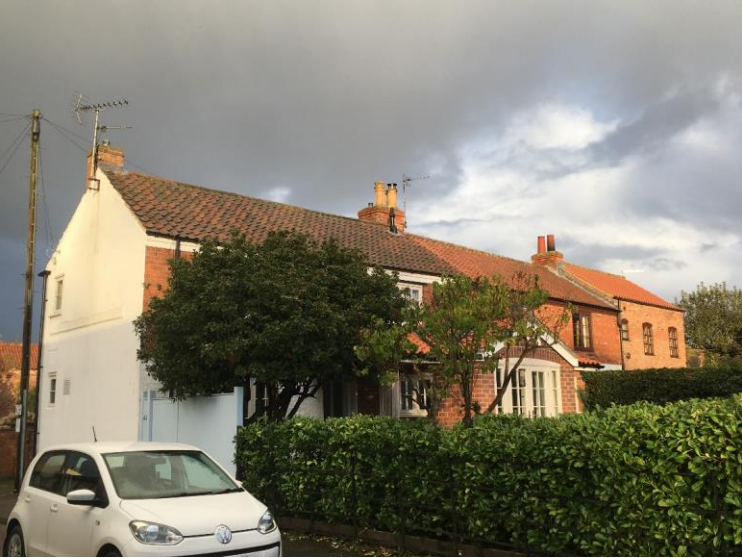
Address	Southdeane 44 Low Street North Collingham	
Grid Reference	SK 82870 61734	
Listing	None	
Building Code	Low 44	
Description	South facing terraced cottage. Evidence of timber framing, and blue Lias stone on northern wall. Likely to be early modern.	
Photograph

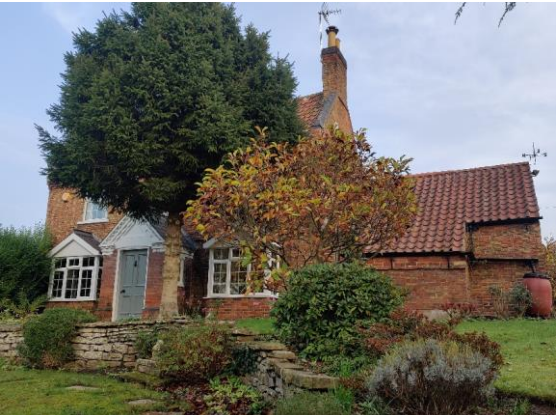
Address	Lane End was The Homestead 58 Low Street North Collingham
Grid Reference	SK 82908 61820
Listing	Grade II 1156974
Building Code	Low 58
Description	"House, mid-C18 with C19 additions. Brick with pantile roofs, cogged eaves, coped gables, 2 gable stacks: 2 storeys plus garrets, 3 windows, L-plan. Central C19 gabled porch colour washed, containing panelled door, flanked by single C20 gables bay windows with 3 light casements. Above C18 glazing bar sashes, C19 addition to south."
Photograph

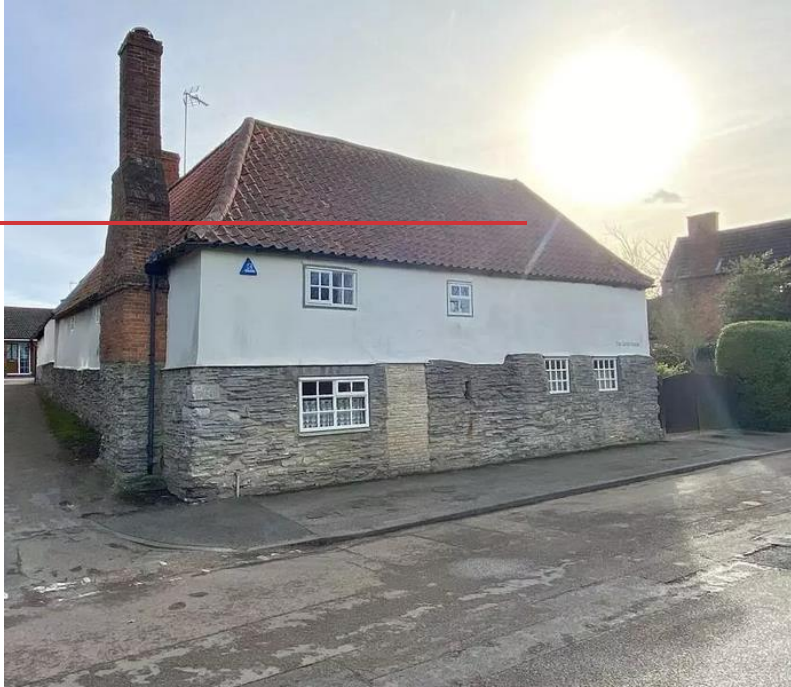
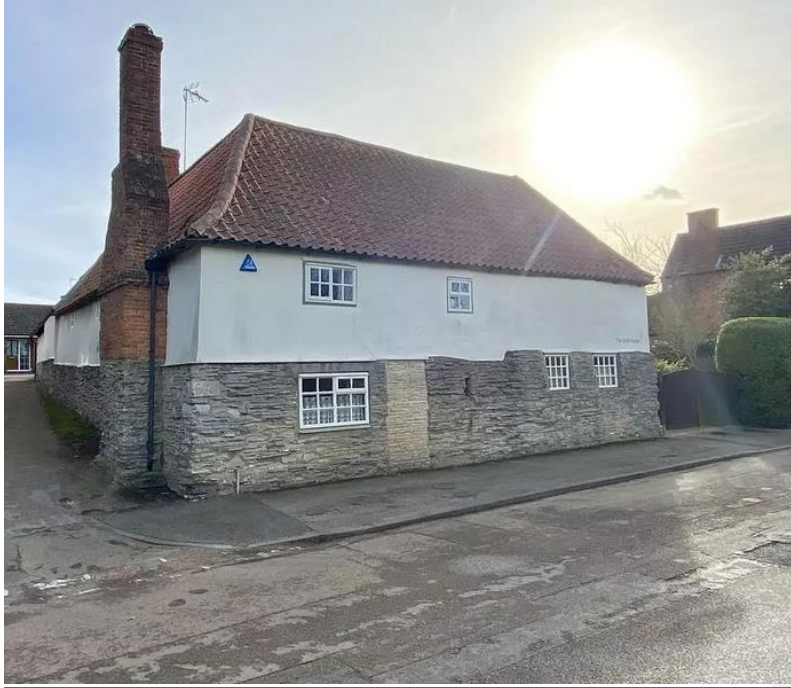
Address	White House 68 Low Street North Collingham
Grid Reference	SK 82919 61892
Listing	Grade II 1046043
Building Code	Low 68
Description	<p>"House, C16 and C17 with C19 and C20 additions and alterations. Coursed blue Lias rubble and brick with extensive remains of timber framing in interior and at rear. Partly mud and stud and rendered. Hipped C20 pantile roof, single external stack on north gable single ridge stack. 2 storeys, 3 bays, L-plan. Off centre C20 panelled door flanked by single C20 2 light glazed bar casements: beyond to south C19 close boarded door. Interior has on 1st floor 3 bays of timber framing, later staircase cutting through span beam, oak bressummer fireplace dated 1757."</p> <p>Potentially built on the hall house plan and could be mediaeval or early modern.</p>

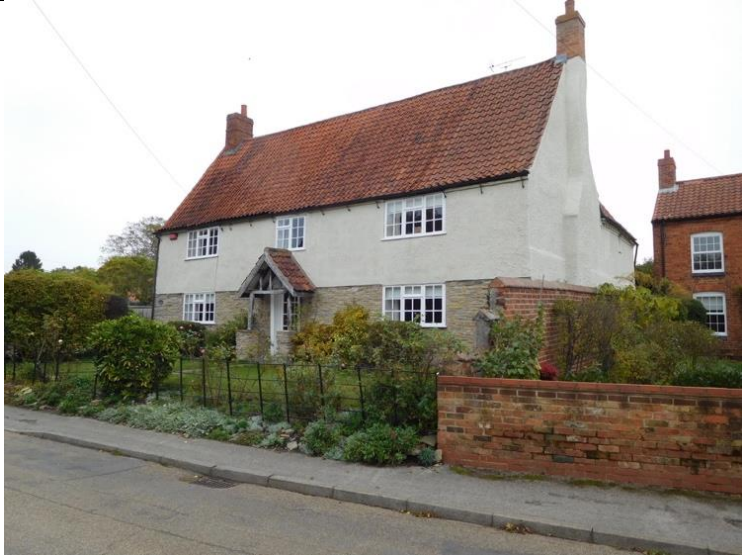
Address	The Malthouse 86 Low Street North Collingham	
Grid Reference	SK 82961 62159	
Listing	Not listed	
Building Code	LOW86	
Description	Nottinghamshire vernacular with blue Lias ground floor. First floor in render on timber frame. Steep roof pitch with pantile roof. The name refers to malthouses which stood behind this house and have since been demolished.	
Photograph

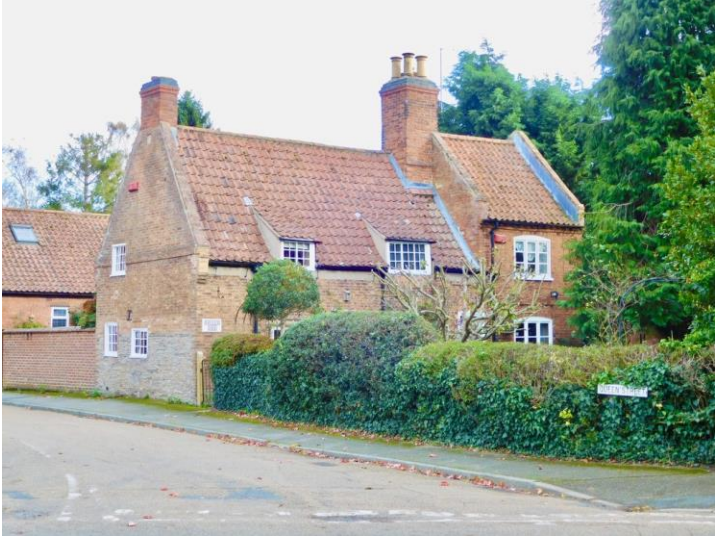
Address	Ercles Cottage 104 Low Street North Collingham	
Grid Reference	SK 83022 62271	
Listing	Grade 2 UID 1369935	
Building Code	LOW104	
Description	Nottinghamshire vernacular with blue Lias ground floor gable. First floor part in render possibly timber framed. Steep roof pitch with pantile roof. Parapet gable walls.	
Photograph

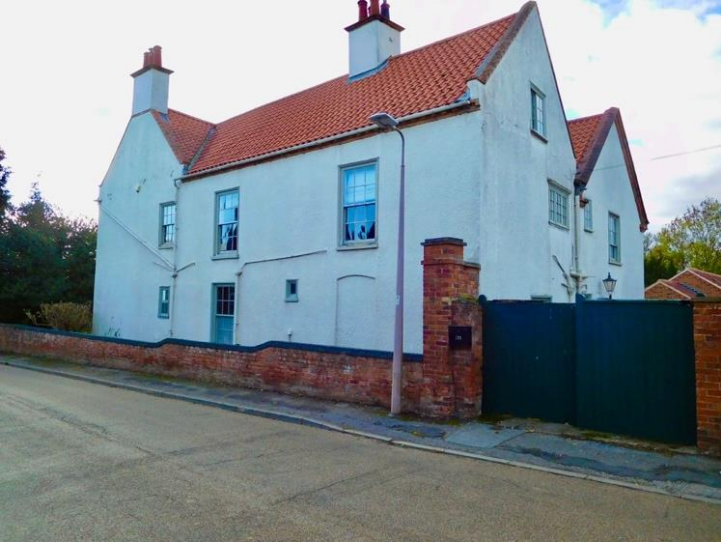
Address	The Willows 105 Low Street North Collingham	
Grid Reference	SK 82950 62218	
Listing	Not Listed	
Building Code	LOW105	
Description	Much altered and extended early modern house. Walls are rendered but has blue Lias walls at low level. Steep pitched roof with parapet gables. The floor plan shows the rear part of the house has 1m thick walls with a typical vernacular layout.	
Photograph

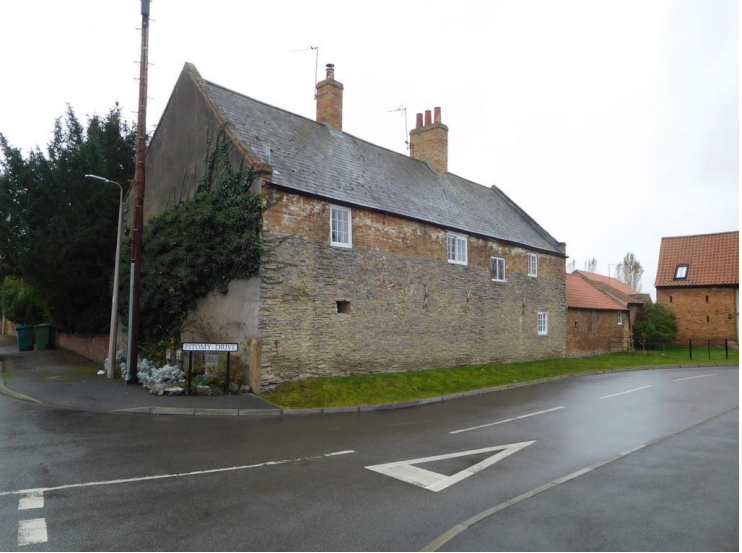
Address	Holly Farm 119 Low Street North Collingham	
Grid Reference	SK 82983 62289	
Listing	Grade 2 UID 1046040	
Building Code	LOW119	
Description	"Farmhouse, C17, coursed blue Lias rubble and brick, part rendered, Welsh slate roof, stone sills, brick coped gables, 2 ridge stacks, 2 storeys, 3 windows. Off-centre moulded doorcase with scrolled brackets to hood, containing C19 half-glazed door, flanked to west by 2 light glazing bar Yorkshire sash with segmental head; beyond, C19 half-glazed door. To east, 2 C19 2 light leaded Yorkshire sashes. North elevation has, above, single glazing bar casement, 2 C19 2 light Yorkshire sashes, single fixed light."	
Photograph

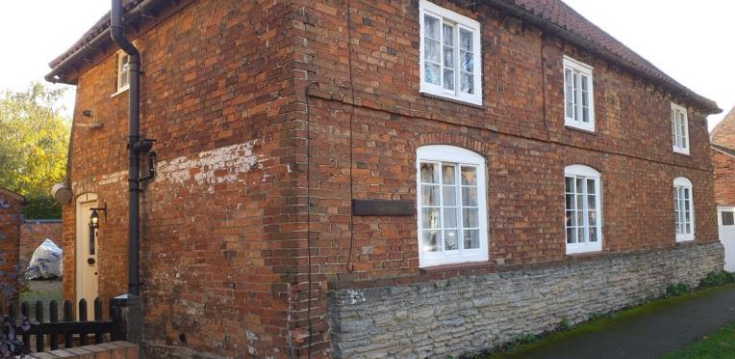
Address	Valian Cottage 126 Low Street North Collingham	
Grid Reference	SK 83169 62384	
Listing	Grade 2 UID 1046046 (This looks like an error as address is wrong)	
Building Code	LOW122	
Description	Early modern house with later extension. Blue Lias and hand made brick walls. Later hipped and pantiled roof. Small section of original first floor timber framing still visible.	
Photograph

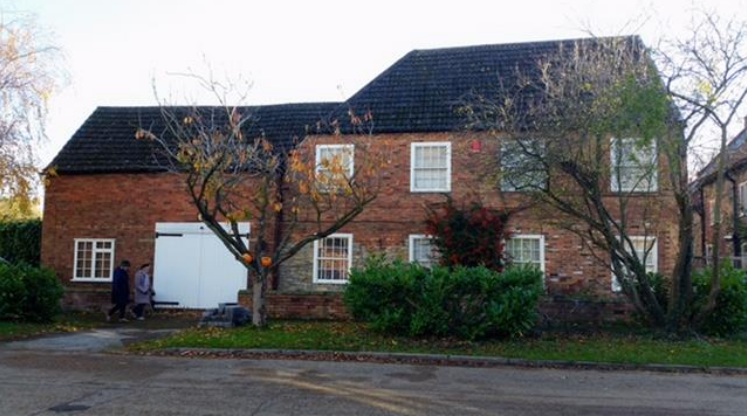
Address	134 Low Street North Collingham	
Grid Reference	SK 83196 62390	
Listing	Not Listed	
Building Code	LOW134	
Description	Early modern house. Hand made brick walls. Blue Lias walls at low level. Steep pitched pantile roof.	
Photograph

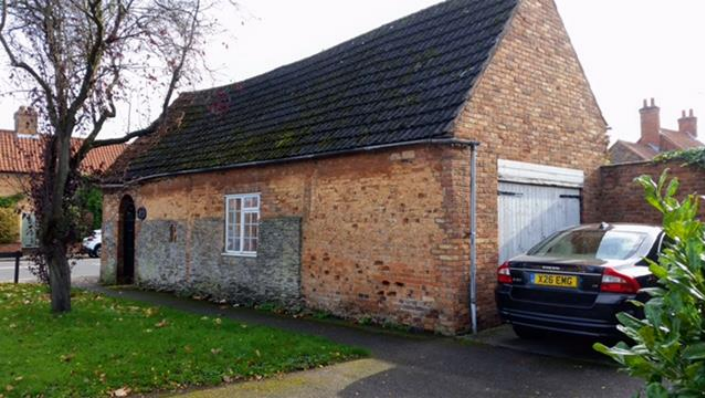
Address	The Forge 136 Low Street North Collingham	
Grid Reference	SK 83212 62395	
Listing	Not Listed	
Building Code	LOW136	
Description	Early modern house. Hand made brick walls. Blue Lias walls at low level. Steep pitched roof. Original window bricked up in the Lias wall. Records show its use as a forge in early 1900's. Possibly a cottage prior to this.	
Photograph

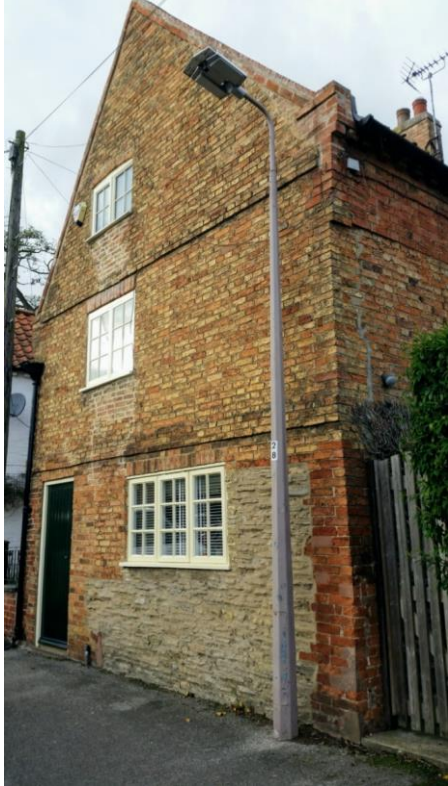
Address	Malt Kiln Cottage 165-167 Low Street Collingham	
Grid Reference	SK 83171 62418	
Listing	Grade 2 UID 1302629	
Building Code	LOW165-167	
Description	<p>"Pair of cottages, late C17, coursed blue Lias rubble and brick, steep pitched pantile roof, two coped gables, 2 off-centre ridge stacks, 1st floor and eaves brick bands. Part rendered. 2 storeys with garrets, 5 windows. Off-centre C20 gabled brick porch, containing C20 glazed door, flanked by single C19 2 light glazing bar casements; beyond, C20 glazing bar French window, C20 glazing bar fixed light in segmental head. C20 flat roofed extension to north has C20 Tudor style door and C20 casement. Above, 3 two and 3 light glazing bar Yorkshire sashes, that to south in segmental head, and 2 C20 2 light glazing bar (top hung) casements."</p>	
Photograph

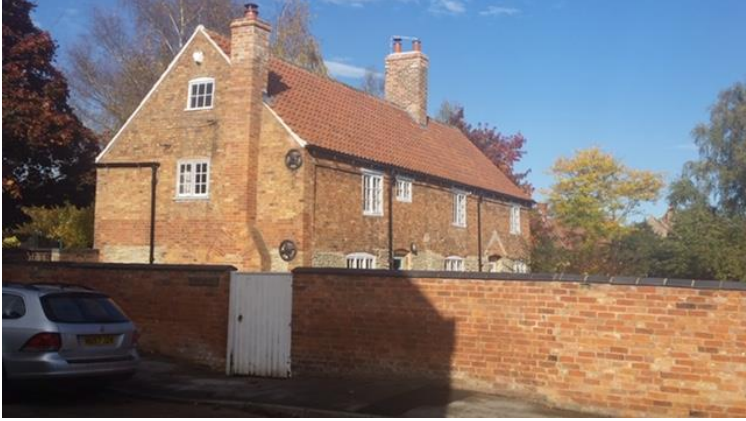
Address	The Old House 4 Queen Street Collingham	
Grid Reference	SK 83187 62319	
Listing	Grade 2 UID 1157022	
Building Code	QUEEN4	
Description	<p>"House, 1680. (The beam inscribed with this date has been removed by the present owner). Coursed blue Lias rubble and brick, brick eaves, steep pitch pantile roof, remains of timber framing; off-centre ridge stack, single external stack on south gable. 2 storeys, 3 bays. Off-centre C20 gabled porch containing C20 close-boarded Tudor style door, flanked by single C19 3 light glazing bar casements in segmental heads; beyond, C19 close-boarded door and single C19 3 light glazing bar casement in segmental heads. Above, 3 C19 2 light glazing bar Yorkshire sashes, single C19 light glazing bar casement. South gable has C19 2 light casement on 1st floor, single C19 fixed light to garret, both in segmental heads."</p>	
Photograph

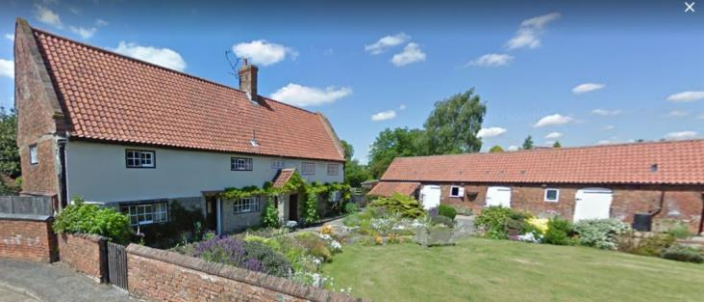
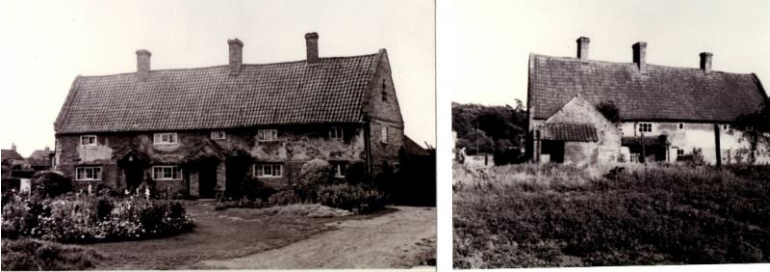
Address	The Nunnery 8 Southend South Collingham	
Grid Reference	SK 826016 61269	
Listing	Grade II 1046048	
Building Code	Southend 8	
Description	"Farmhouse, late C16. Coursed blue Lias rubble and brick, timber framing with pargetted rendering, steep pitch pantile roof, brick coped gables, off-centre ridge stack, eaves level brick band. 2 storeys with garrets, 3 bays, 5 windows, I-plan. Gables not at right angles to front elevation. Small first floor windows."	
Photograph

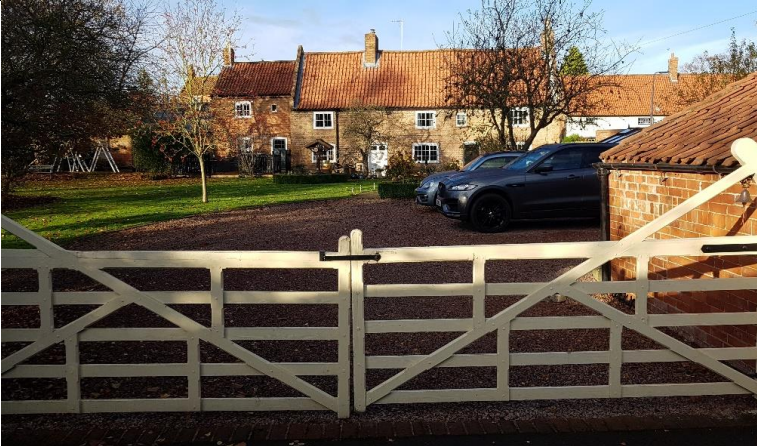
Address	Fruit Farm 15 Southend South Collingham	
Grid Reference	SK 82620 61238	
Listing	Not listed	
Building Code	Southend 15	
Description	Formerly 3 cottages now joined. Early C18, with blue Lias foundations. Small door hatches in gables. May have been living quarters for labourers, bedding and clay pipes once found in the roof. Asymmetric roof profile at north end.	
Photograph

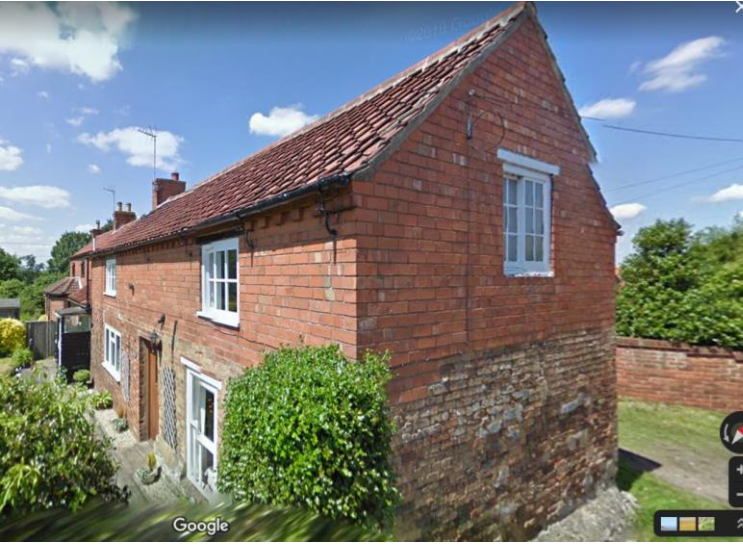
Address	16 Southend South Collingham	
Grid Reference	SK 82526 61220	
Listing	Not listed	
Building Code	Southend 16	
Description	Cottage, early C18 and C19. Extensive blue Lias. Bricks covering or replacing Lias on roadside suggest timber framing.	
Photograph

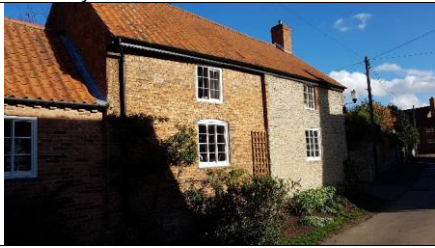
Address	The Old House 6 Westfield Lane Collingham
Grid Reference	SK 82712 61366
Listing	None
Building Code	Westfield6
Description	Vernacular cottage with Lias and handmade brick walls, thatched roof replaced with pantiles in 1953 and modern single storey extension added in 1980's. Evidence of pre-1550 timber framing internally.
Photograph

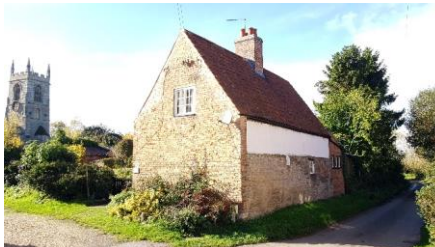
Address	One Acre or Crockers Cottage 7 Westfield Lane Collingham
Grid Reference	SK 82707 61363
Listing	None
Building Code	Westfield7
Description	North Notts vernacular cottage with Lias walls and timber framed and rendered upper floor, one and a half storey with steep pitched roof with a central chimney. Single storey extension added in early 1900's. A post pad survives in the north-east corner, the rendered north elevation is stepped back from the Lias below and is suggestive of timber-framing and, the west gable has evidence for a clasped purlin roof structure
Photograph
