Collingham Uncovered

Level 1 historic building survey of selected structures in Collingham, Nottinghamshire; incorporating assessments of 12 Bell Lane and 6 Westfield Lane

Dr James Wright FSA,
Triskele Heritage, Sneinton, Nottinghamshire

January 2023

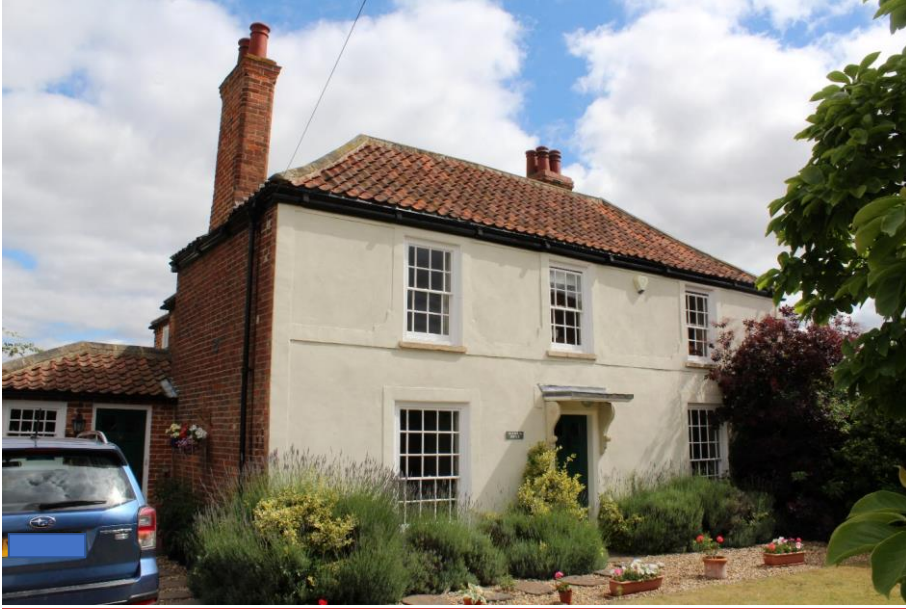
Figure 9 12 Bell Lane. Looking north-east.

12 Bell Lane (known as The Nook) lies to the north of Bell Lane at NGR [SK 82889 61628](#) ([Figure 9](#) & [Figure 10](#)).^{***} It is a grade II listed building (NHLE 1046066) dated to the seventeenth century, with later remodelling. The building is two storeys in height, with a cellar ([Figure 11](#)) and attic ([Figure 12](#)). The main frontage, facing south, is three bays wide. It has blue Lias stone footings, but is otherwise rendered brickwork ([Figure 9](#)). The property is now a double pile structure, with later, single and double storey extensions to the west and north respectively ([Figure 10](#)). The building fabric is a mixture of blue Lias stone, handmade and machine-made brick. The roof is clad with pantiles.

During Phase 2 the western arm and structure at the crook of the L-shaped building were ~~was~~ demolished or remodelled and the vernacular-style house was given a polite Georgian makeover. The south elevation was developed in rendered brick with a new build to the west of the surviving Phase 1 structure (Figure 9). The original timber-framed element of the eastern arm of the L-shaped building was clad or buried in brickwork. This presented a symmetrical appearance with sash windows and a central doorway, with a porch canopy supported on volute scrolls, leading into an entrance passage (Figure 23). The standard Georgian arrangement of dining room and withdrawing room at the front of the building was achieved and it is anticipated that a kitchen may have been situated where ~~is~~ the modern study is now located (Figure 10). Above, the roof structure was reconfigured to the extent that there is no evidence for the early modern arrangement surviving. Instead, a hipped, single purlin, common rafter roof rests on the inserted brickwork rather than the relict wall plate observed at first floor level (Figure 12 & Figure 18).

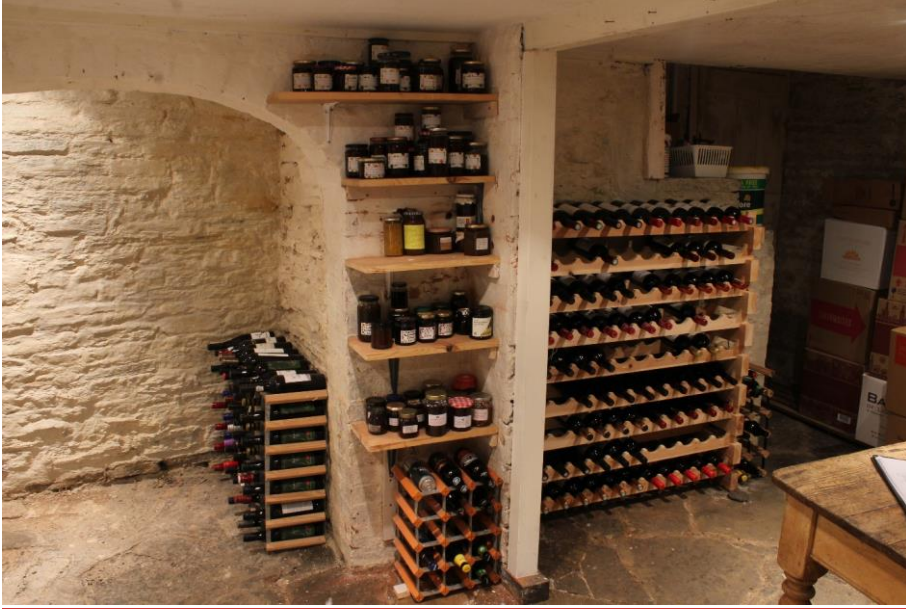
Figure 11 Cellar of 12 Bell Lane. Looking north. Note the chimney foundations behind the wine racks.

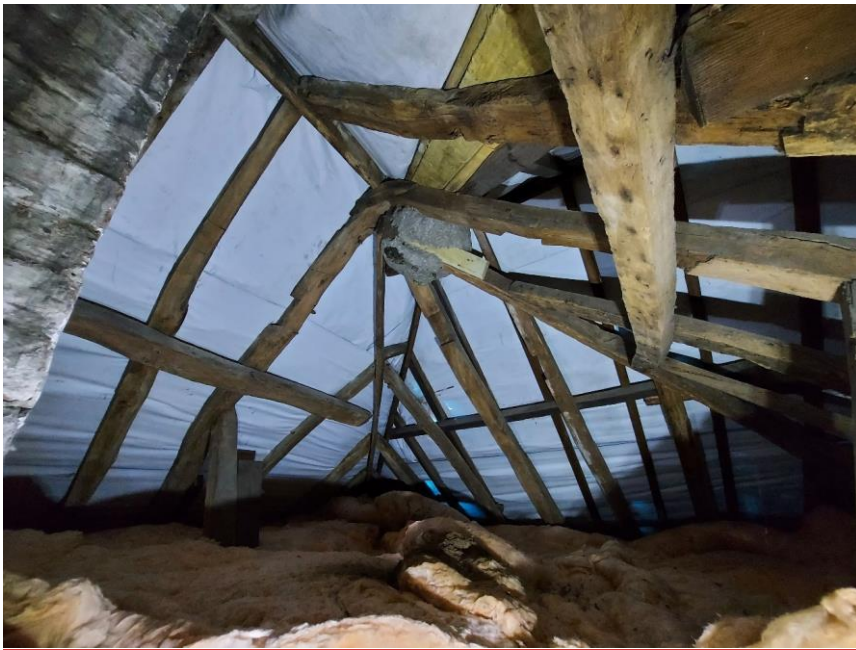
Figure 12 Attic of 12 Bell Lane. Looking south-east.

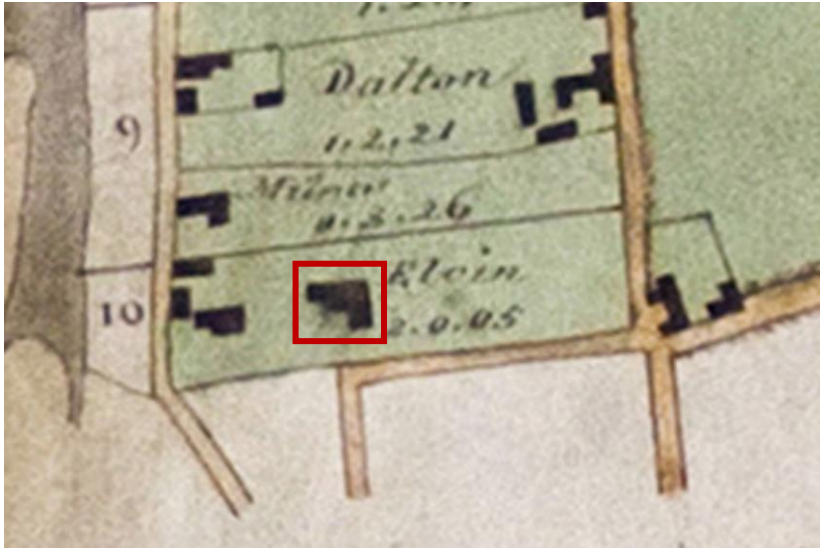
Figure 13 12 Bell Lane on the 1790 enclosure map of North Collingham (Picture Source: Nottinghamshire Archives, EA 111/2)

The property is represented on the ~~enclosure~~ map of North Collingham, dated 1790, as an L-shaped building with a structure at its ~~the~~ crook ([Figure 13](#)).^{(NA) ***} Only the eastern arm of the L-shape could be sensed archaeologically, and this is taken to be the oldest surviving phase of the house. ~~At ground floor this comprises, comprising~~ the dining room (to the south ([Figure 14](#))) and ~~the~~ study (to the north ([Figure 15](#))), with a chimney stack and party wall between. The east-west wing of the L-shape appears to have been demolished; it would have lain beneath what is now the kitchen ([Figure 16](#)). The structure at the crook of the L-shape was possibly a porch, ~~that may have incorporated incorporating~~ a stair, but has been remodelled beyond recognition or, more likely, demolished and replaced as part of the current entrance hall.

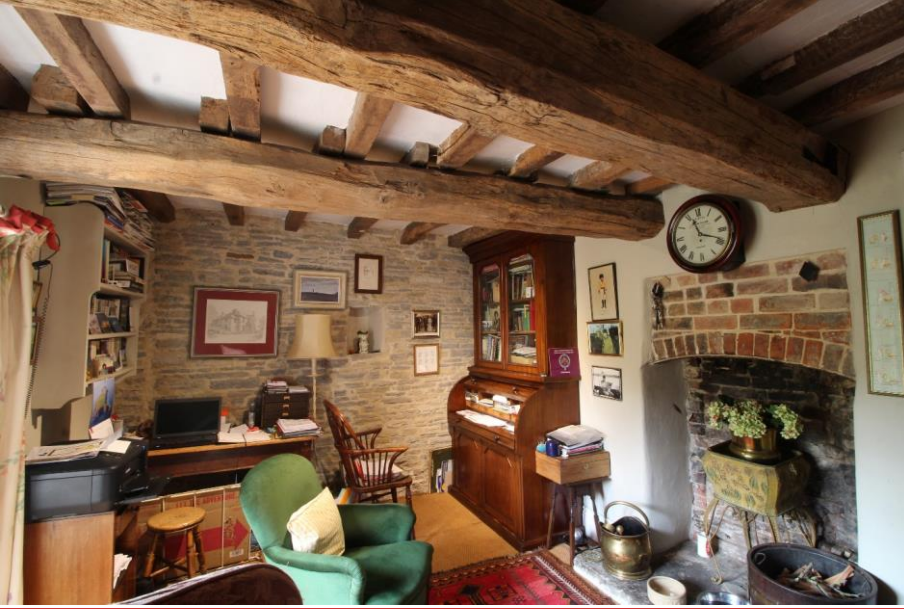
Figure 15 Study of 12 Bell Lane. Looking east.

Phase 1 of the building is represented by a combination of blue Lias stonework and timber-framing. Blue Lias was observed as low footings to the south and north elevations ([Figure 17](#)) and a longitudinal wall on the east elevation ([Figure 15](#)). This pattern of stone footings to the transverse elevations and walls reaching ~~top~~ first floor on the longitudinal elevations can be seen throughout Collingham, including at 6 Westfield Lane ([see below](#)). There is a small, stone-lined cellar, accessed from the entrance lobby, beneath the eastern bay of the south range ([Figure 11](#)). It contains the stone foundations of the chimney stack which ~~appears appear~~ to be part of the primary build.

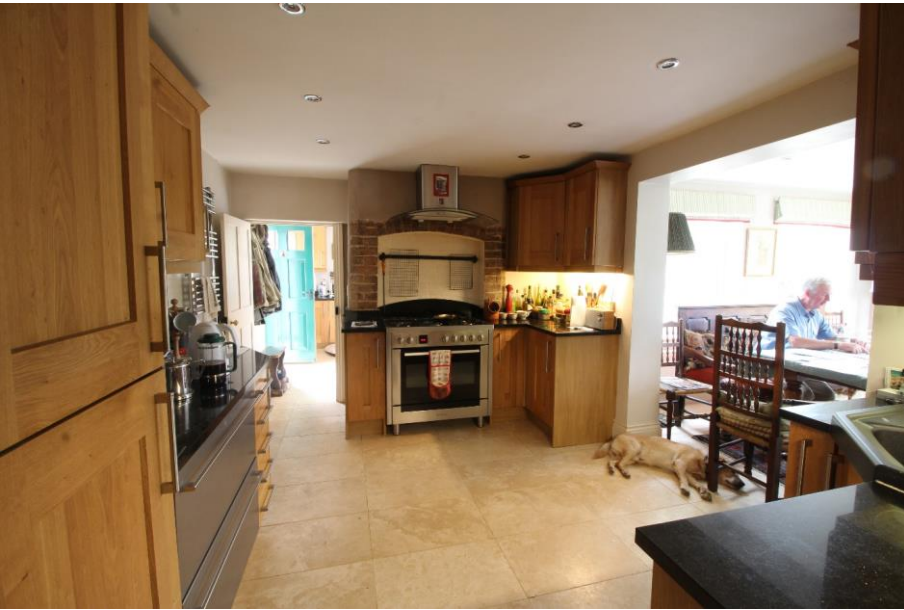
Figure 16 Kitchen of 12 Bell Lane. Looking west.

Phase 4 involved building out to the west and north of the Phase 3 structure (Figure 10 & Figure 26). This took place during the twentieth century and was carried out using modern machine-made red bricks. This work created an entrance hall to the west and involved a reconfiguring of the ~~space~~ to the north to include an open plan kitchen-diner (Figure 16).

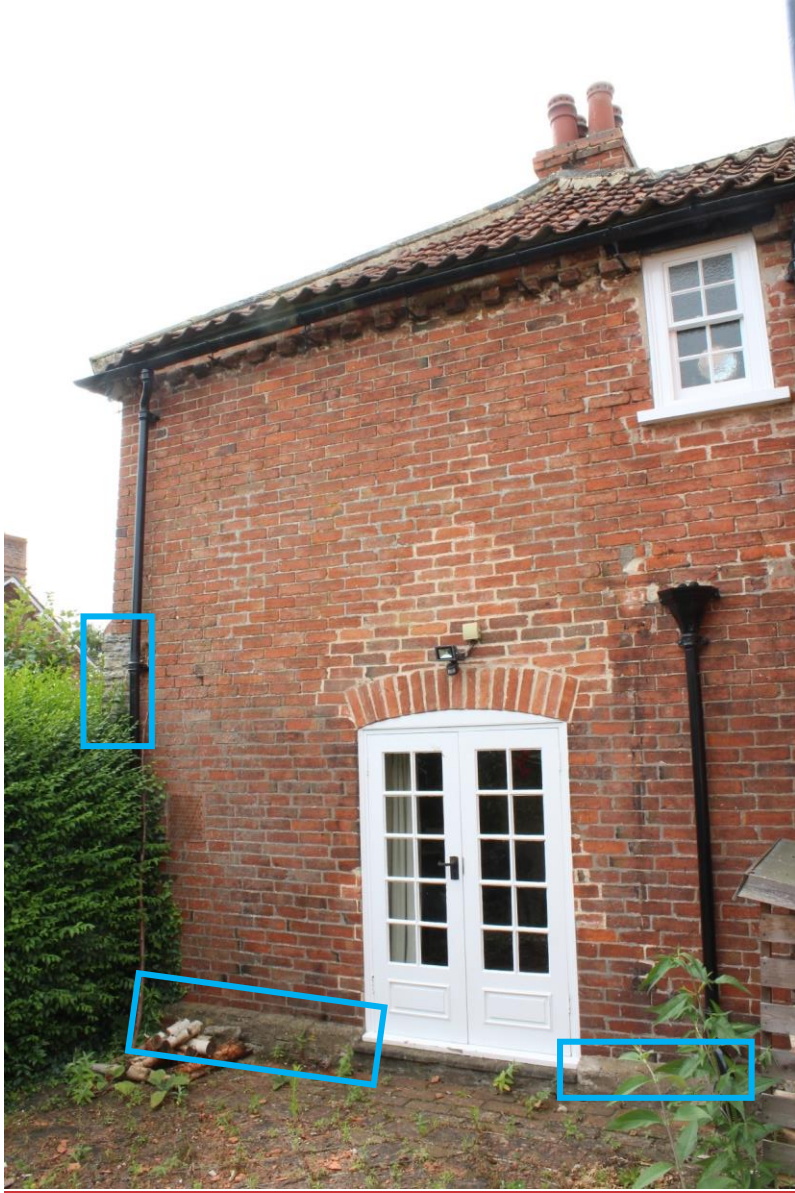
Figure 17 North elevation of 12 Bell Lane. Looking south. Note the presence of blue Lias stonework (highlighted in blue).

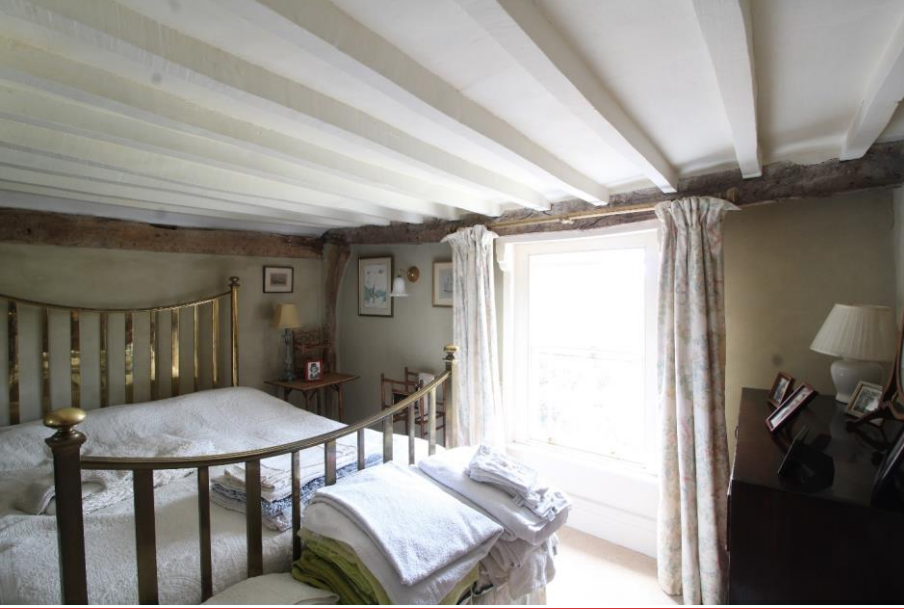
Figure 18 South-east bedroom at first floor of 12 Bell Lane. Looking south-east.

Timber-framing is visible internally at first-floor level. The south-eastern bedroom has an exposed wall plate to the east and south with a jowled post at the junction ([Figure 18](#)). The southern wall plate has relict mortices on the soffit ([Figure 19](#)). ~~These are taken to be which are~~ evidence for the removal of wall studs. A double-chamfered spine beam, with scroll stops, runs east-west and supports north-south orientated ceiling joists ([Figure 20](#)). To the north,

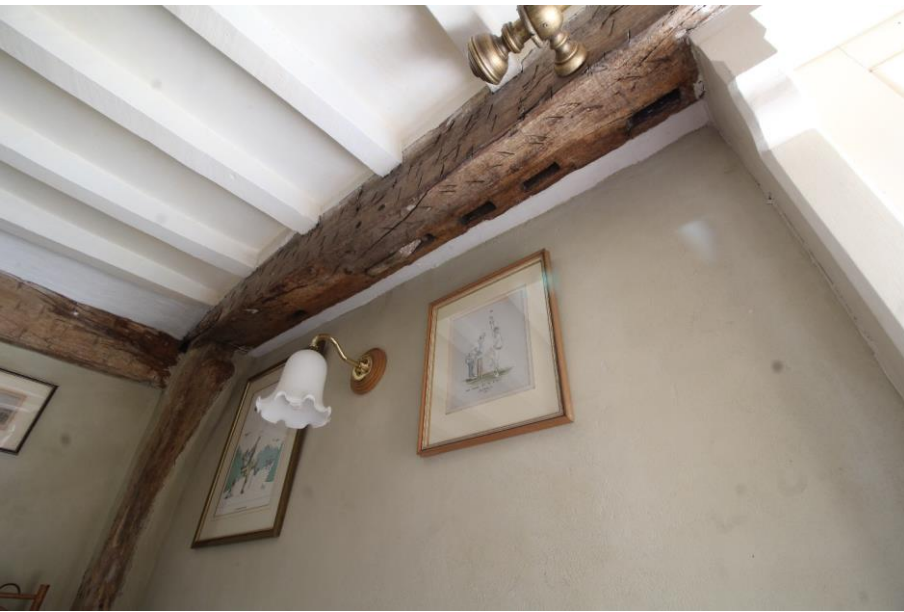
Figure 19 Soffit of south wall plate in south-east bedroom at first floor of 12 Bell Lane. Looking south-east. Note the relict mortises for wall studs.

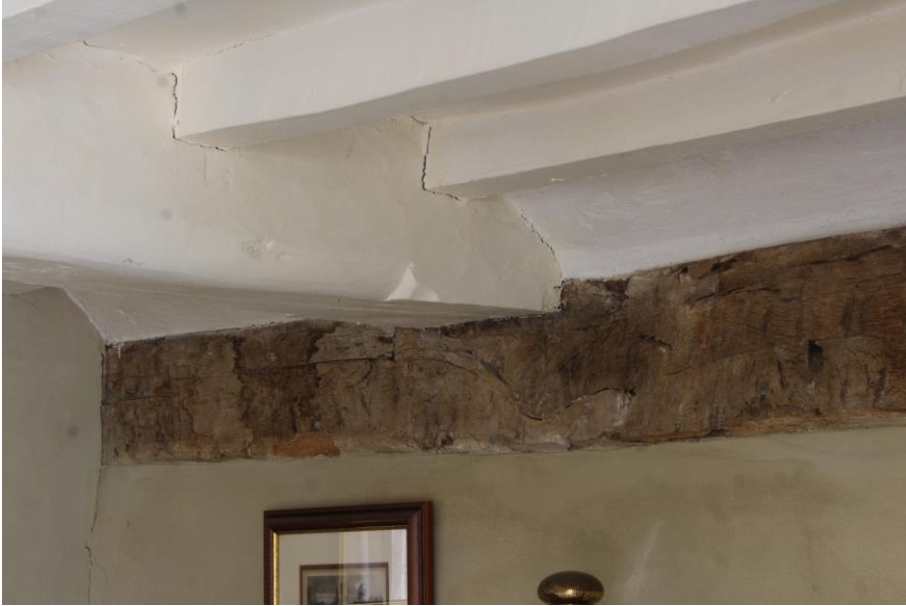
Figure 20 Detail of the spine beam of the south-eastern bedroom at the first floor of 12 Bell Lane. Looking north-east. Note the chamfer stop.

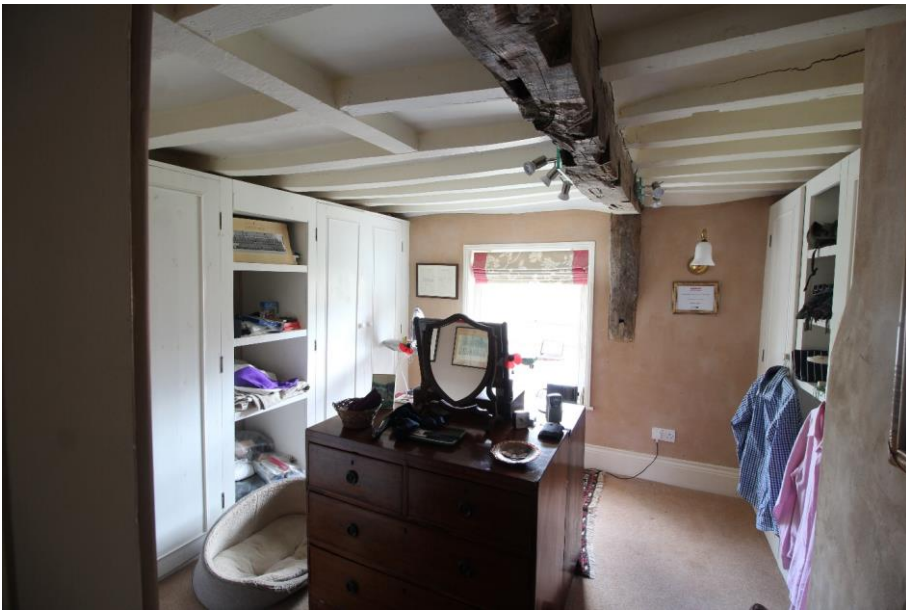
Figure 21 North-east bedroom at first floor of 12 Bell Lane. Looking east. Note the relict mortises in the spine beam.

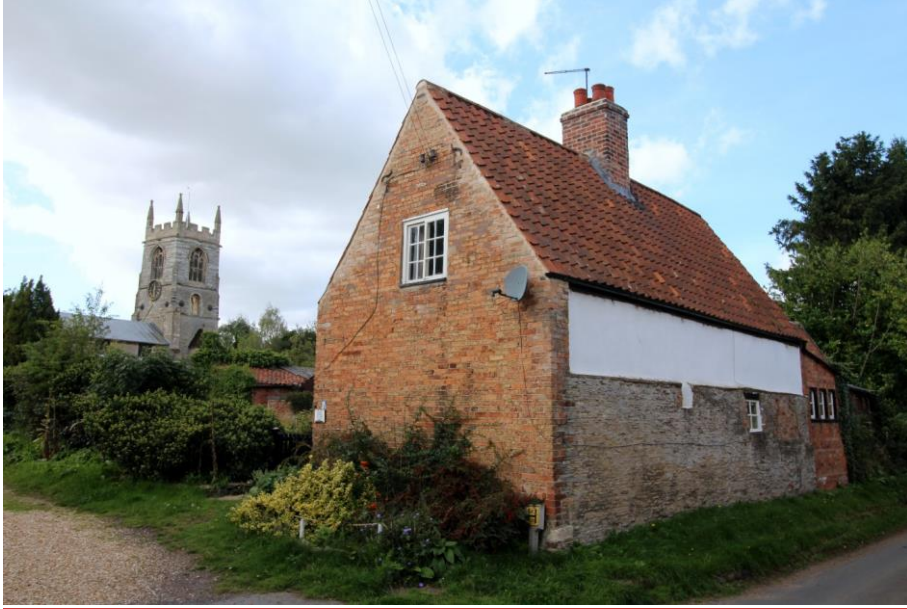
Figure 22 7 Westfield Lane, Collingham. Looking south-west. Note the blue Lias to first floor height on the north elevation.

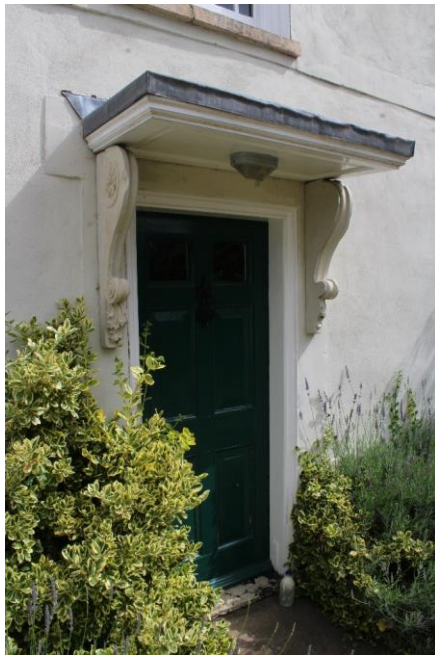
Figure 23 Porch of 12 Bell Lane. Looking north-east.

Dating evidence for ~~the Georgian period~~ Phase 2 comes from the use of red-purple handmade brickwork (uncommon in Nottinghamshire before the very end of the seventeenth century), the formal symmetry of the south elevation, the sash windows and porch. Internally, features from this era include surviving window shuttering in the withdrawing room (Figure 24) and a latch lifter on the attic door (Figure 25). It is anticipated that the lime ash flooring of the attic may also date to this period.

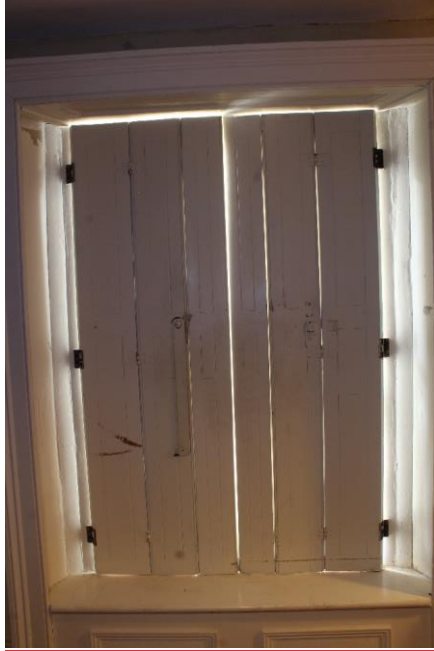
Figure 24 Window shuttering for the ground floor withdrawing room of 12 Bell Lane. Looking south.

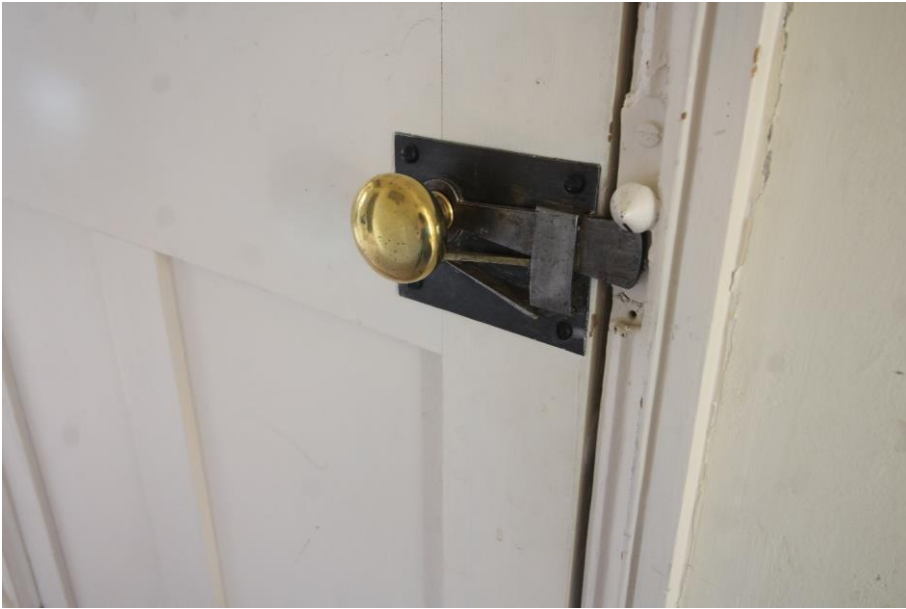
Figure 25 Latch lifter of the attic door at 12 Bell Lane. Looking north-east.

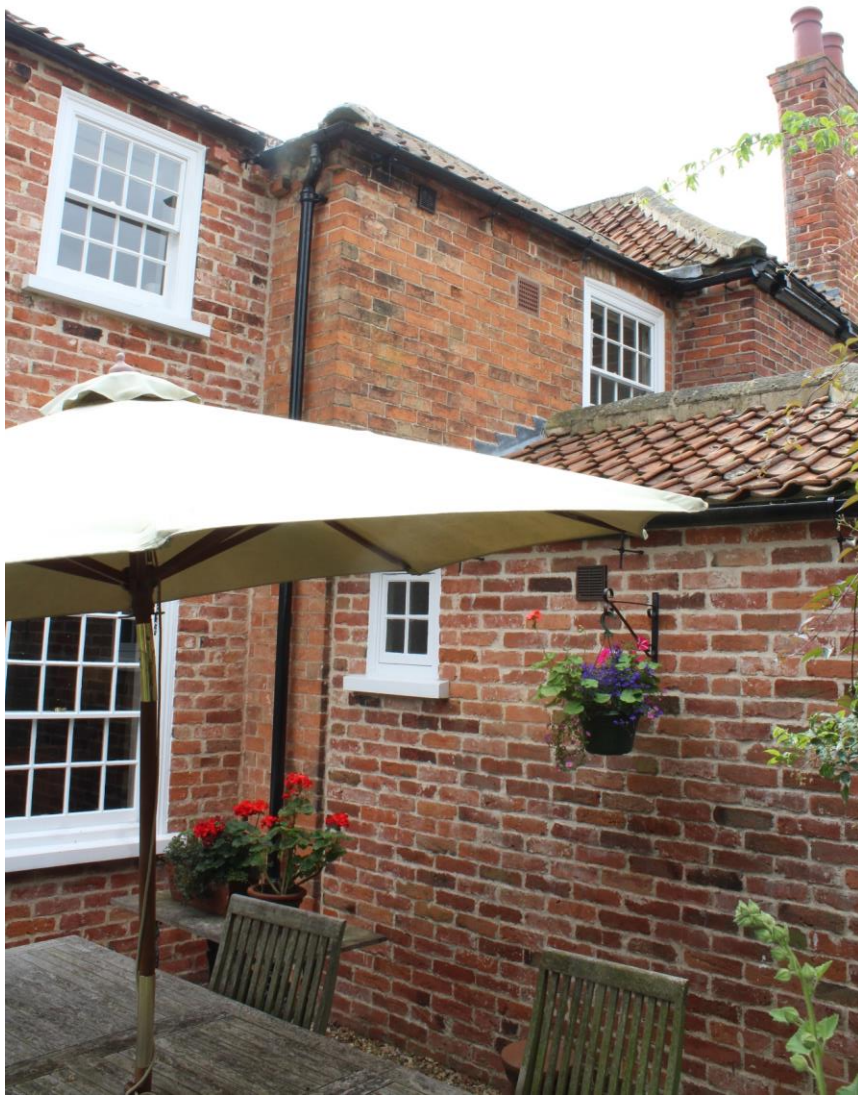
Figure 26. West elevation of 12 Bell Lane. Looking south-east.

A small rectangular Phase 3 build, now largely buried within twentieth century extensions to the west and north, can be observed to the north of the eastern Georgian extension (Figure 10 & Figure 26). It survives as a clear straight joint in the masonry of the first-floor west

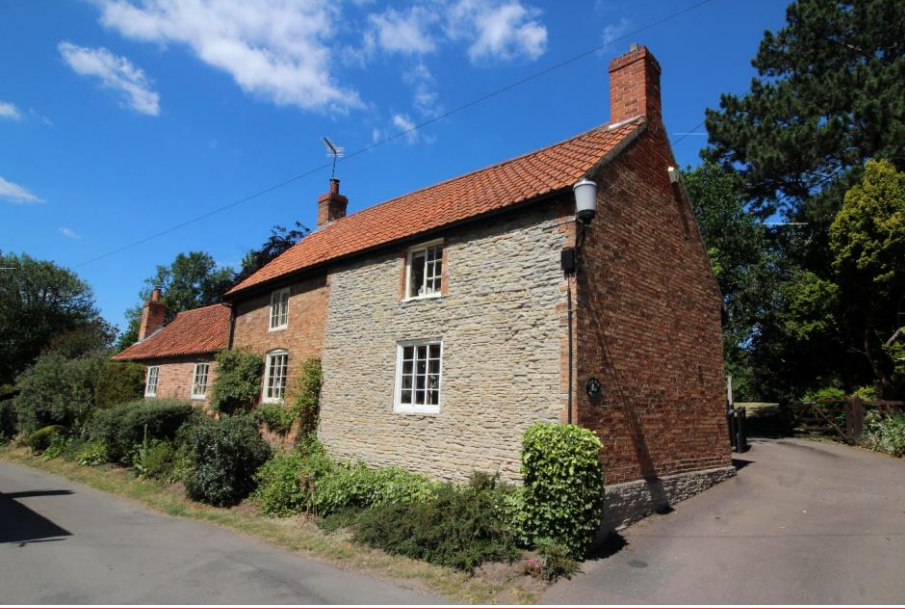
Figure 27 6 Westfield Lane. Looking north.

This property is an unlisted building, standing within South Collingham, to the north of Westfield Lane at NGR 482716 361370 (Figure 27 & Figure 28). The oldest part of the building is a two-bay, brick and stone, two-storey structure with a pantile roof. A single storey, three-bay brick and pantile modern extension lies immediately to the south-west.

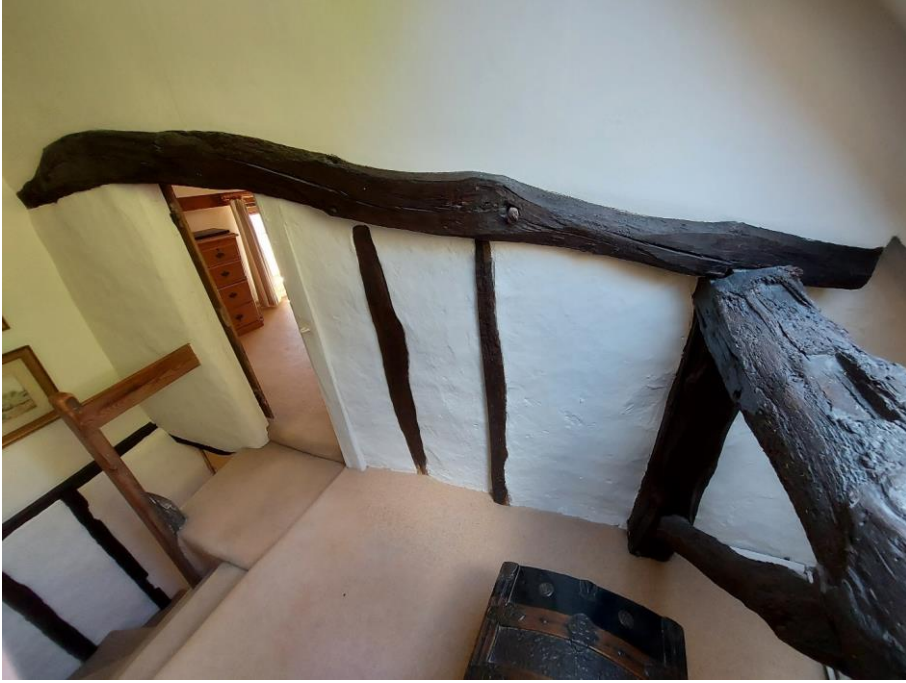
Figure 29 Transverse tie beam and wall studs (left) and longitudinal wall plate with brace and relict mortises for common rafters (right) at 6 Westfield Lane. Looking west.

The primary evidence for Phase 1 of the building can be found at first floor. It constitutes part of the wall and cross frames of a timber structure which ~~appear~~ appears to predate the later external masonry walls (Figure 29 & Figure 30). The wall frame is a relict feature which is visible at the top of the staircase only. It consists of a post and brace supporting a longitudinal wall plate and a transverse tie beam. The wall plate has evidence for relict mortises on its upper face which once supported common rafters (Figure 29). A single example of a relict common rafter is ~~intact in situ~~ at the north end of the visible wall plate (Figure 30). The cambered tie beam does not span as far as the north masonry elevation of the property. However, due to the support of the post it still functions as part of the cross frame between the two bays of the building. A low door allows access between the stair landing and a bedroom to the south. To the north of the door there are two wall studs visible below the tie beam on the east elevation (Figure 29); to the south are four wall studs on the west elevation (Figure 31).

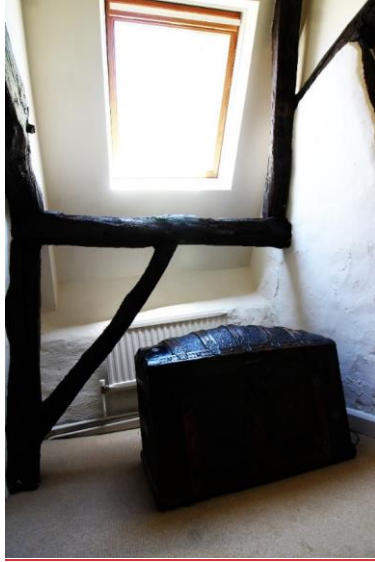
Figure 30 Post, bracing, wall plate and in situ common rafter at 6 Westfield Lane. Looking north.

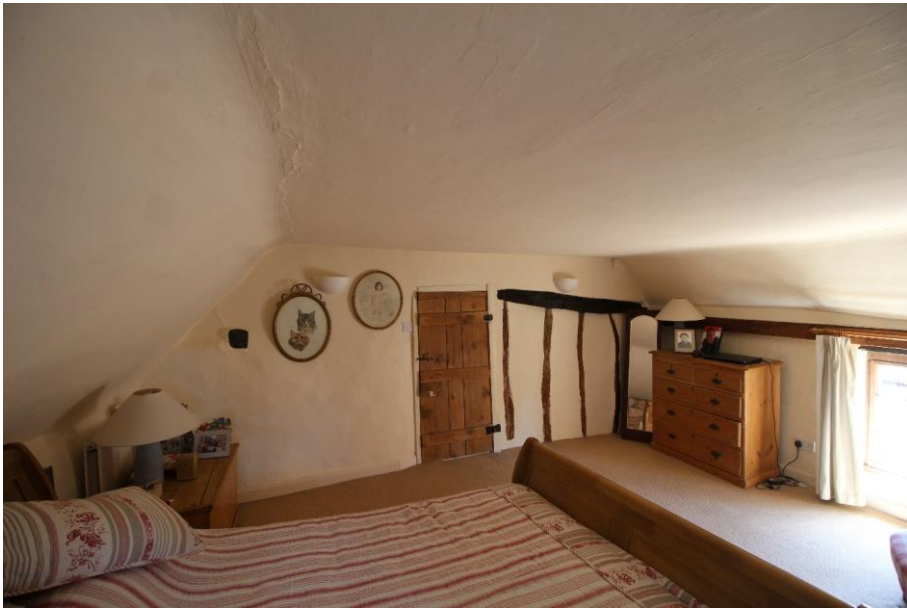
Figure 31 West bedroom of 6 Westfield Lane. Looking east.

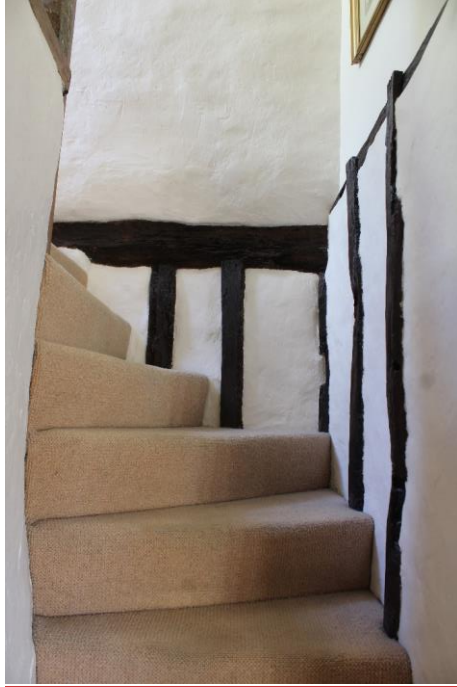
Figure 32 Staircase of 6 Westfield Lane. Looking east.

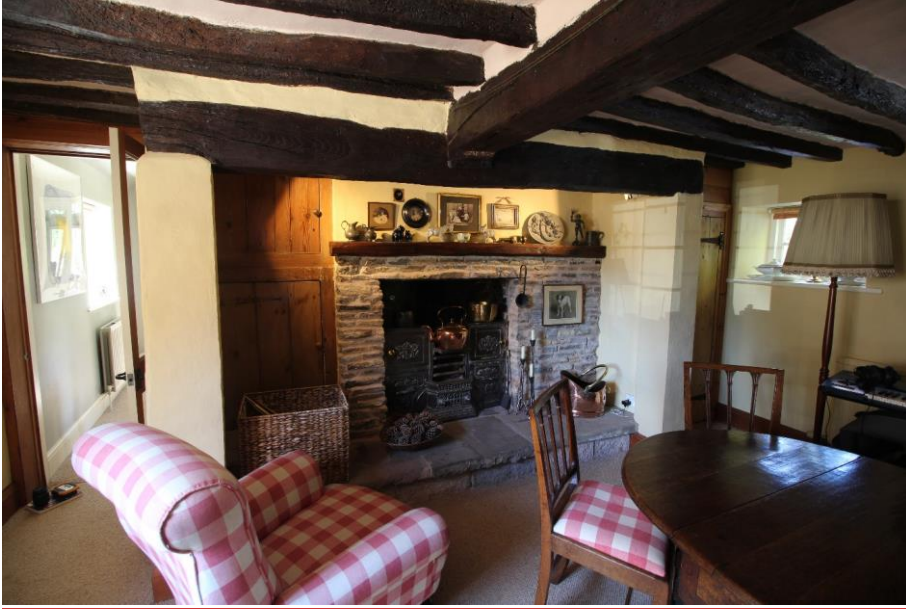
Figure 33 Inglenook fireplace in the living room of 6 Westfield Lane. Looking west. Note the spine beam.

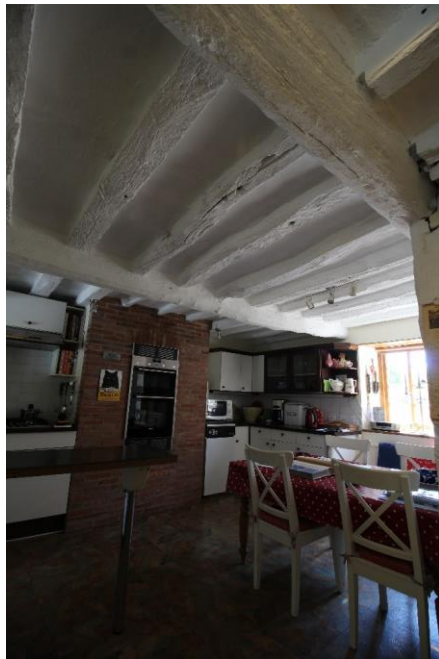
Figure 34 Kitchen of 6 Westfield Lane. Looking south.

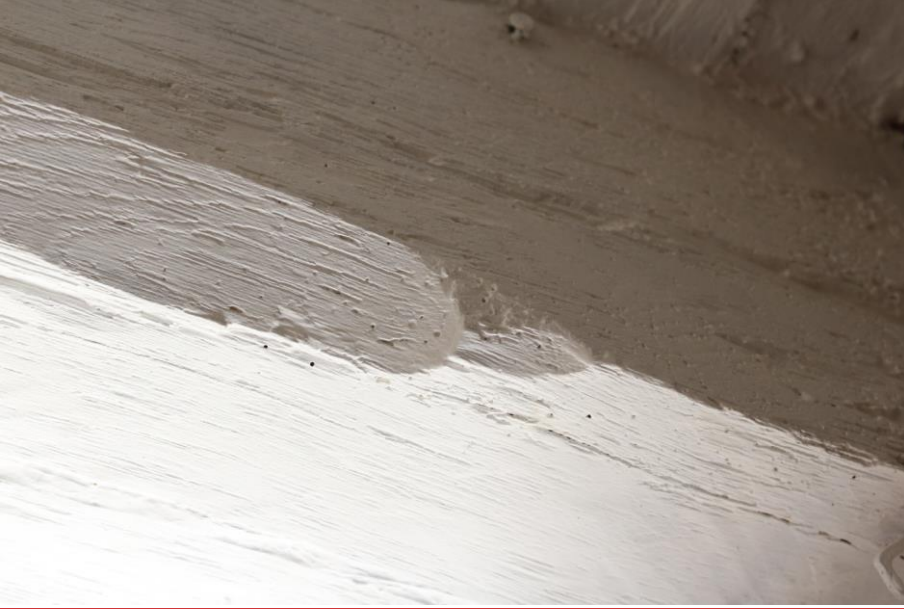
Figure 35 Chamfer stop of the western kitchen bridging beam at 6 Westfield Lane. Looking west.

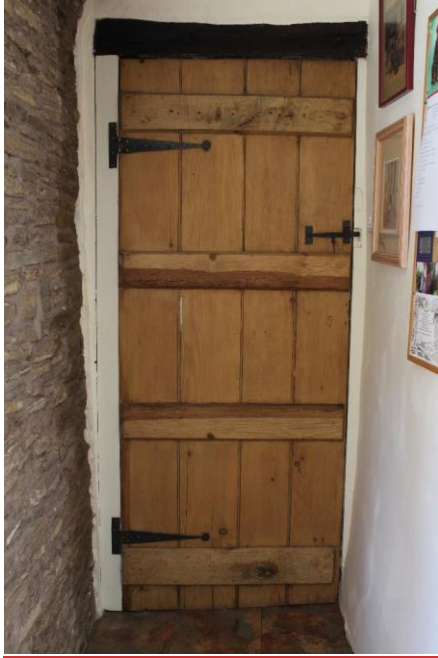
Figure 36 Door between the kitchen and living room at 6 Westfield Lane. Looking west.

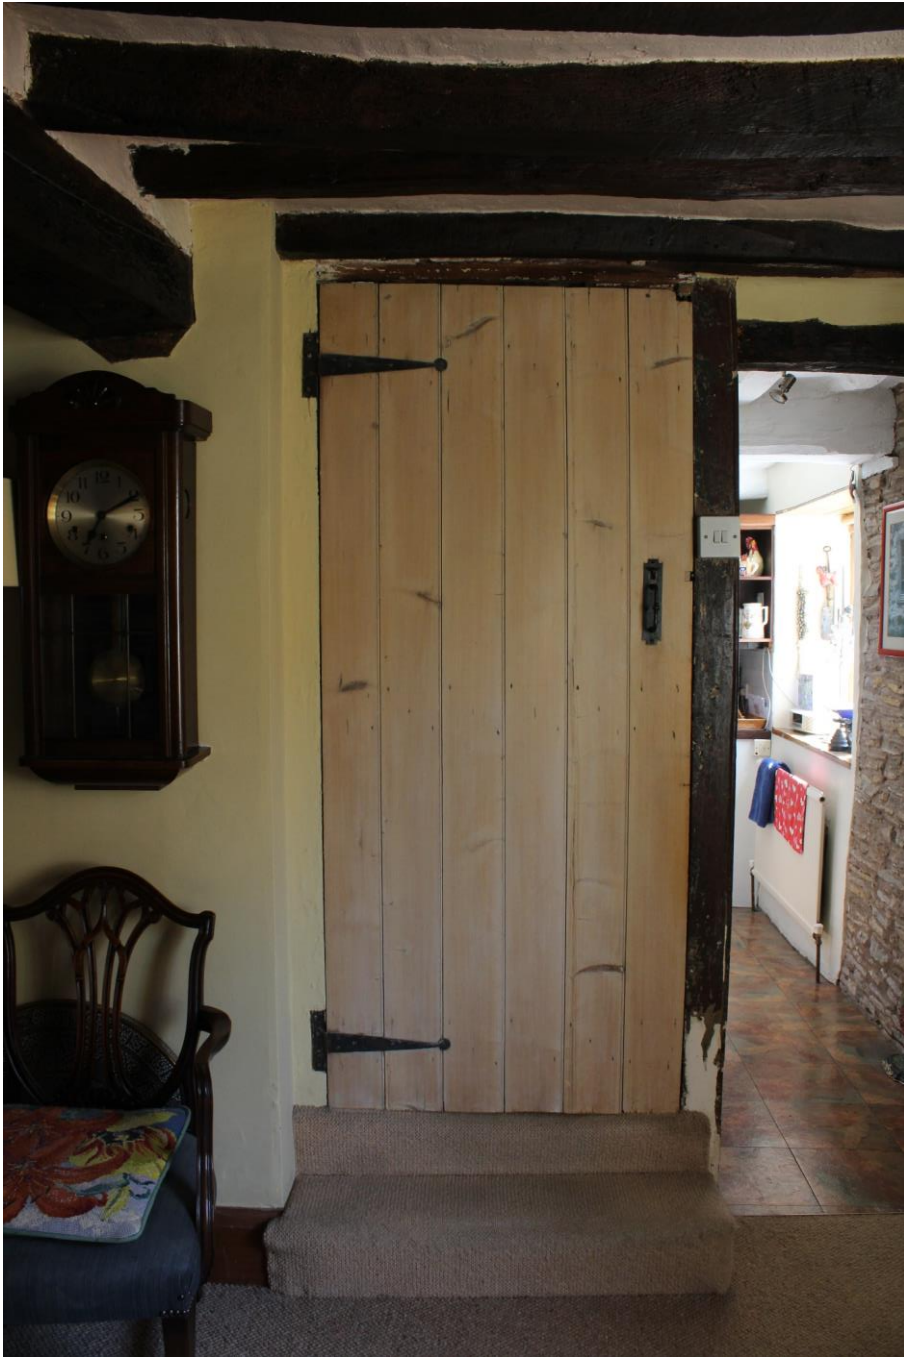
| Figure 37 Stair door at 6 Westfield Lane. Looking east.

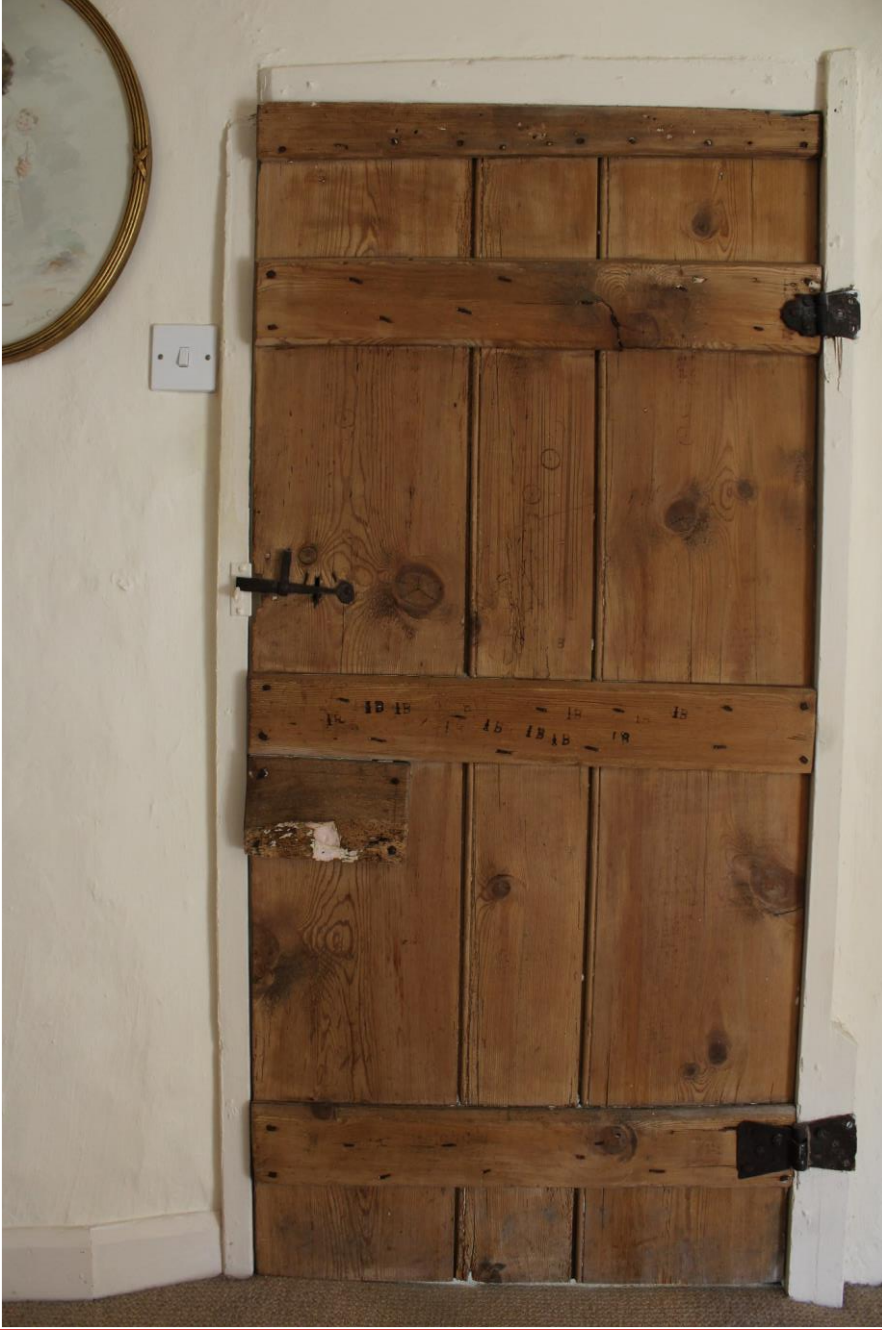
Figure 38 Inner face of the door between the stair and western bedroom at 6 Westfield Lane. Looking east.

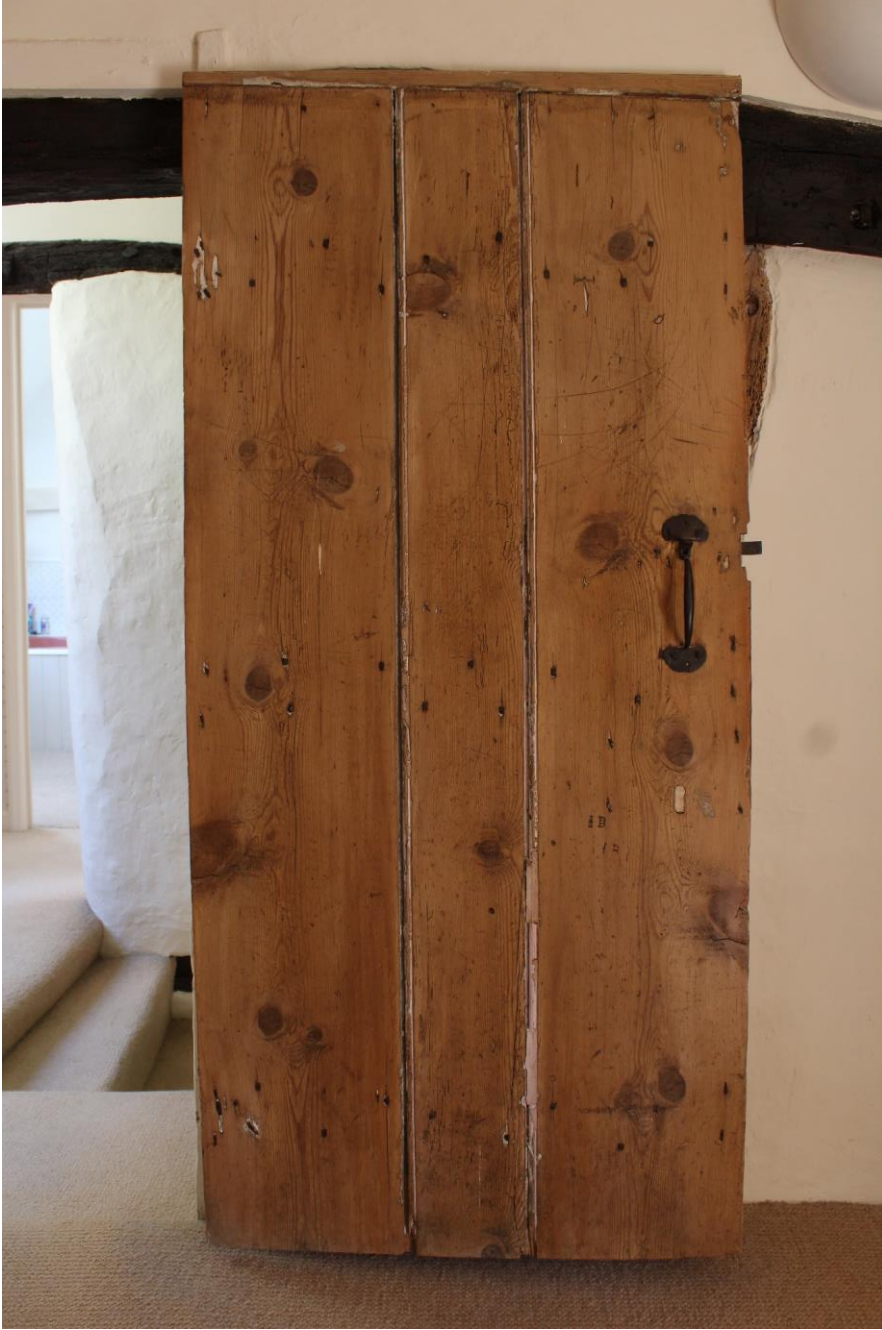
Figure 39 Outer face of the door between the stair and western bedroom at 6 Westfield Lane. Looking east.

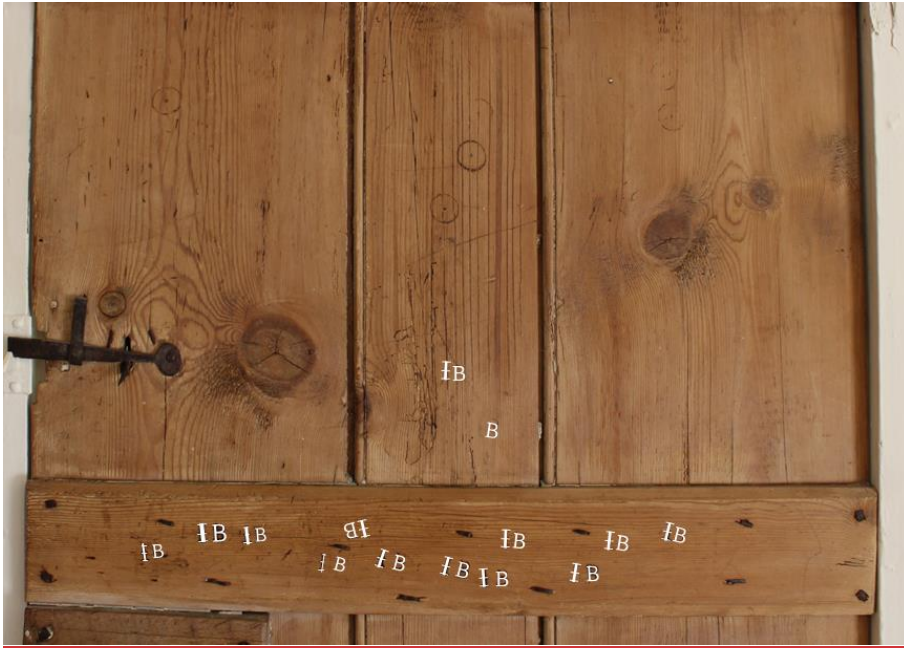
Figure 40 "IB" graffiti on the rear face of the door between the stair and western bedroom at 6 Westfield Lane. Looking east. Photograph has been interpreted with over-drawing.

The bedroom door has 14 examples of the letters "IB" on its rear face – possibly burned on with a heated stamp (Figure 40). An assemblage of scribed lines and arcs, on the outer face, may be evidence for the use of the door as an impromptu workbench for setting out by a carpenter (Figure 41). There are also six inscribed circles or partial circles (Figure 42) and a complete ~~rosette~~ (Figure 43) ~~daisywheel~~ which may be apotropaic marks. The presence of such graffiti is known from other vernacular buildings of the eighteenth century including Kibworth Harcourt Windmill, dated 1773 (Wright 2021).

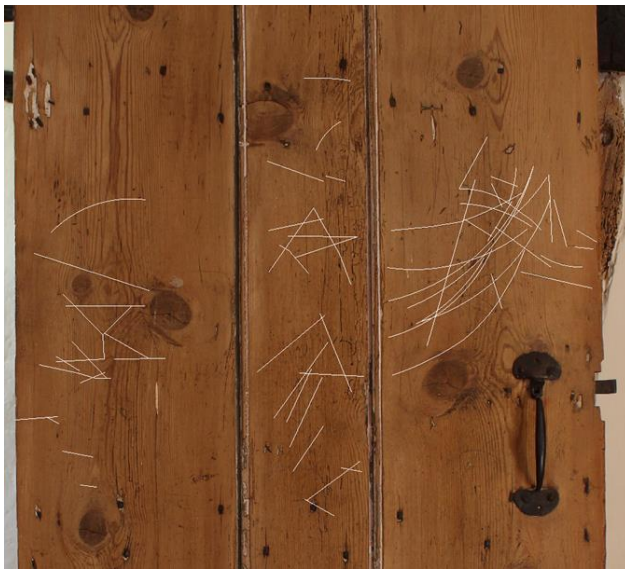
Figure 41 Scribed lines and arcs on the outer face of the door between the stair and western bedroom at 6 Westfield Lane. Looking east. Photograph has been interpreted with over-drawing.

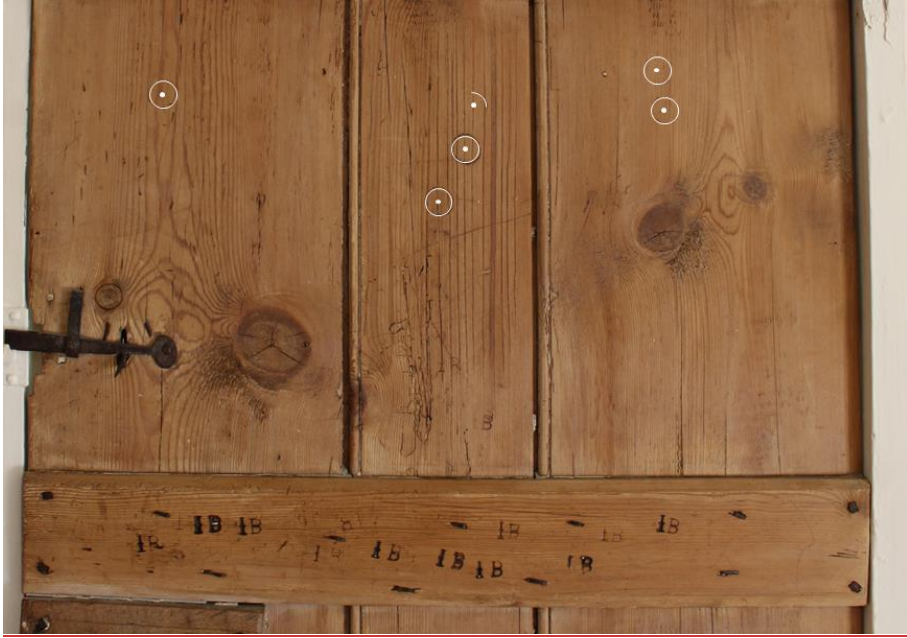
Figure 42. Scribed circles on the inner face of the door between the stair and western bedroom at 6 Westfield Lane. Looking east. Photograph has been interpreted with over-drawing.

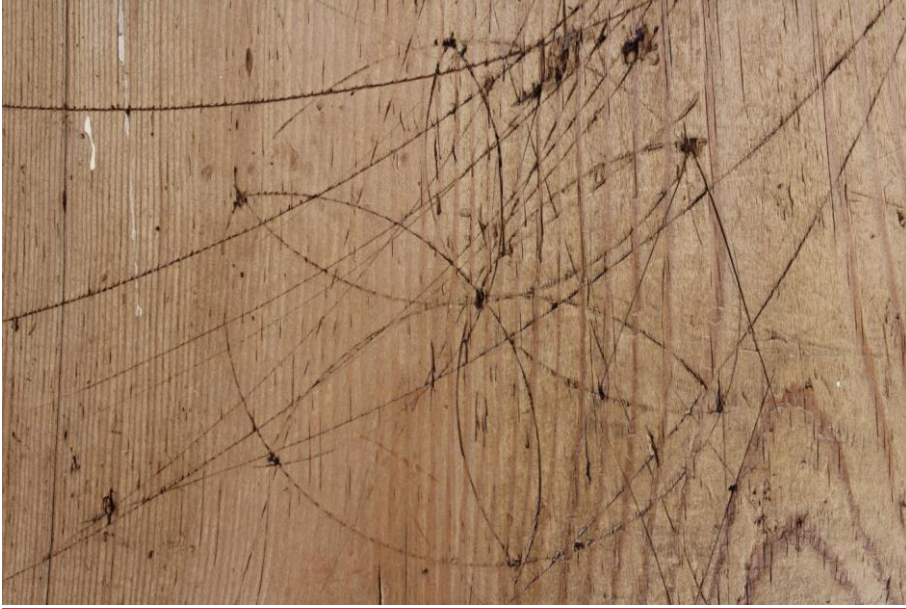
Figure 43 Scribed rosette on the inner face of the door between the stair and western bedroom at 6 Westfield Lane. Looking east.

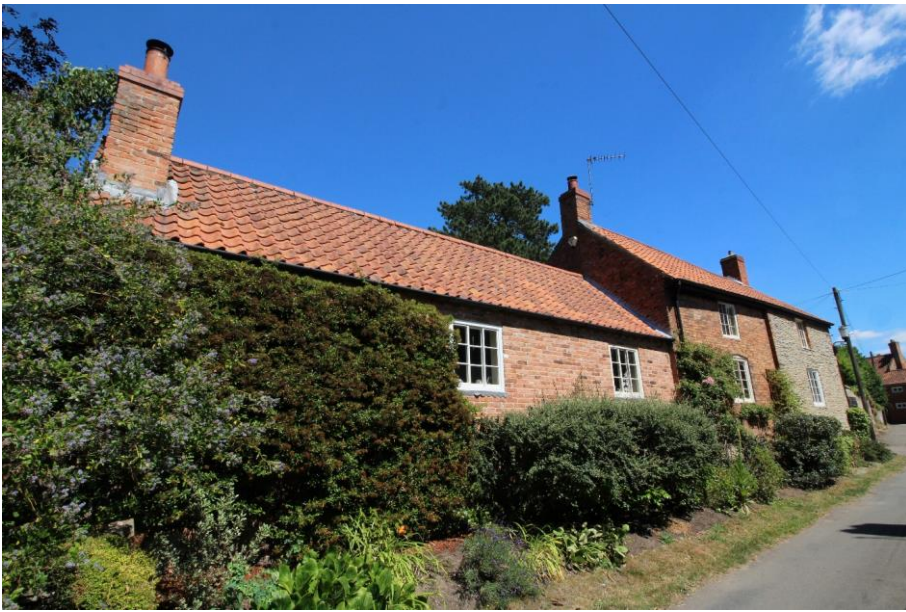
Figure 44 6 Westfield Lane. Looking east.

Phase 4 is represented by a single storey, three-bay brick and pantile modern extension built immediately to the south-west of the older structure during the late twentieth or early twenty-first century (Figure 44). It has a chimney stack in the west gable. The Phase 4 building replaced a smaller lean-to structure which is hinted at by a roof scar on the west elevation of the living room (Figure 45).

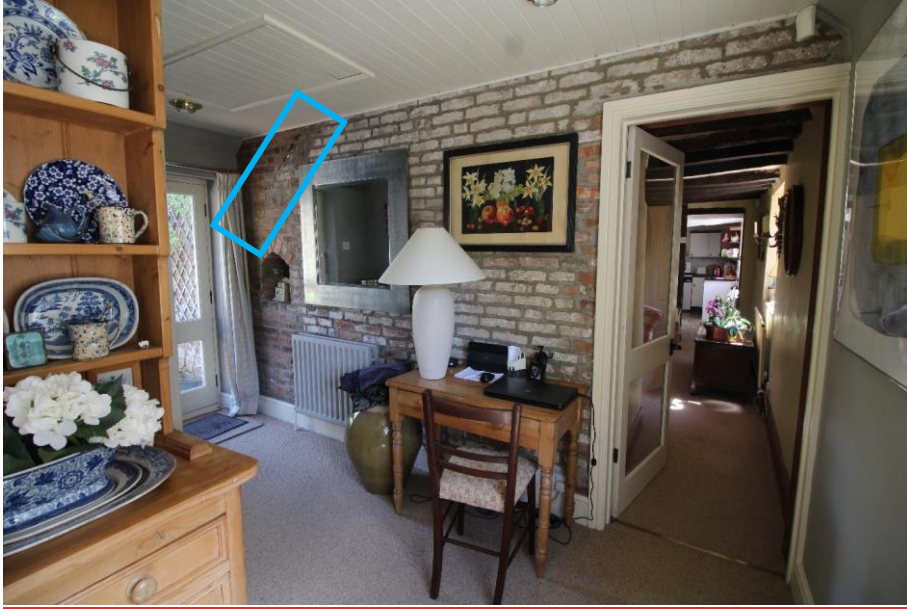
Figure 45 West elevation of the living room at 6 Westfield Lane. Looking east. Note the roof scar highlighted in blue.
